The “Wet Streak Story” – with a happy ending

What can be done to prevent wet streaks? A true story in four chapters

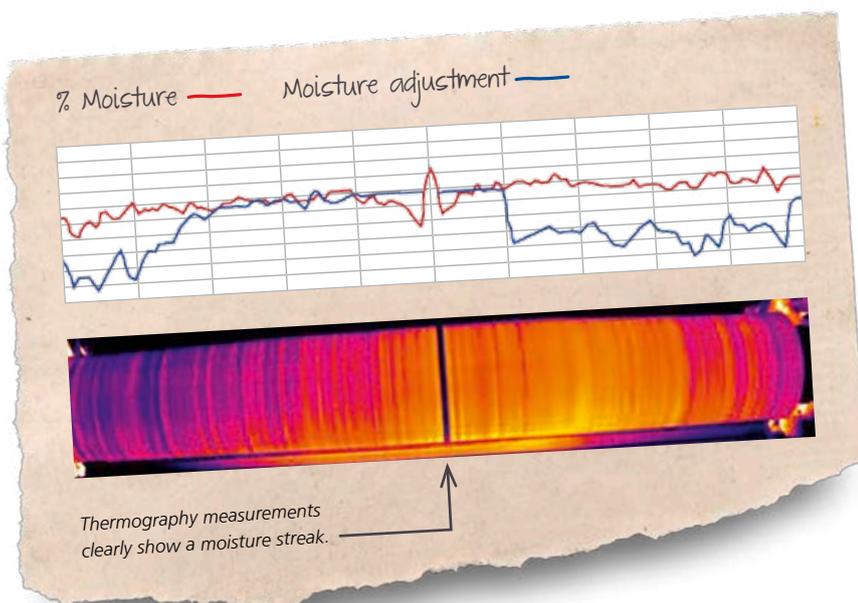
1 Chapter one: Fabric wear

A wet streak in the middle of the sheet led to loss of quality on a **newsprint**

machine (1,500 m/min, 10.3 m fabric width). The machine speed had to be reduced, meaning a significant loss of production. Together with my colleagues from Heimbach TASK I took a closer look **with our infrared camera**. The image recorded a cold (and thus usually moist) streak – measurable on the sheet from the reel up to behind cylinder no. 13. The dryer fabric was checked during a sheet break and a streak was noticed in the middle of the fabric – **a clear indication of the cause of the problem**. After stopping the machine it was confirmed: The fabric was worn locally due to machine conditions and was not able to press the sheet onto the cylinder. **The causes were remedied and the fabric changed**. End of the first chapter!

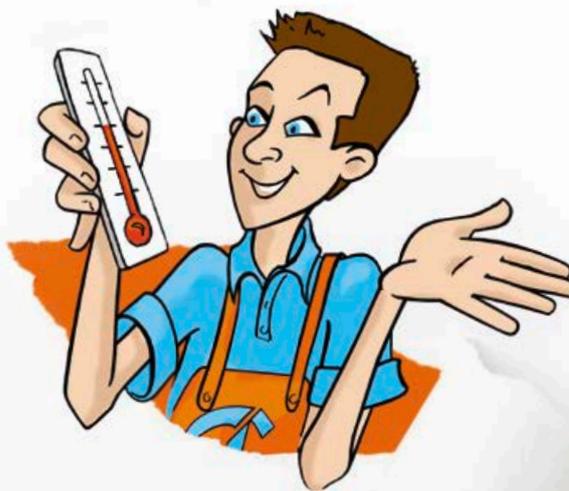
2

Chapter two: Holes in the syphon

The next challenge: A wet streak on the reel and in front of the size press disrupted production on a fine paper machine (764 m/min, fabric width 7.15 m). The thermal imaging camera was once again used. In this case, we found that the streak was first visible downstream of dryer cylinder 1. **To more clearly ascertain where the problem lay**, the surface temperatures on several drying cylinders were measured with a **contact thermometer**. These measurements showed that the temperature at the edge of cylinder 1 was significantly lower than with the other cylinders. **And so the culprit was found:** At the next shutdown the customer opened cylinder 1 and found holes in the syphon – the cause of the wet streak was found and could be eliminated promptly! Turn the page and on to the third chapter.

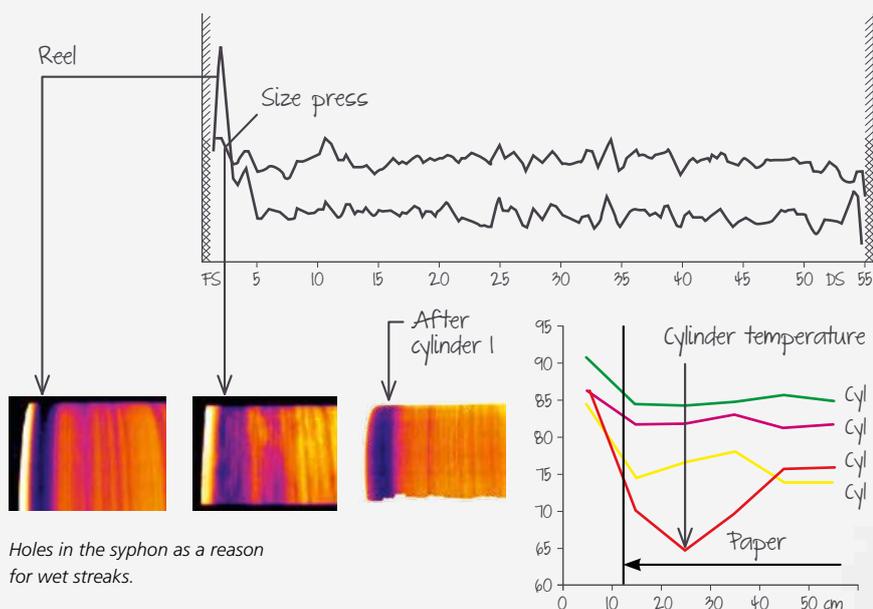
Holes in the syphon as a reason for wet streaks.
