Determination of periodic MD mass variations in the paper sheet

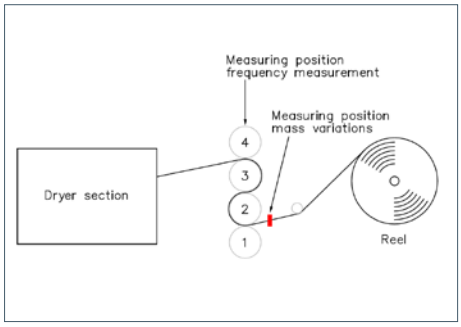
Fig. 4 Measuring Positions Case Study 1

The first measurement on the drive side after the calender (Fig. 4) showed mass variations in the sheet with the frequencies very close to each other of 116.5 and 117.5 Hz (Fig. 5).

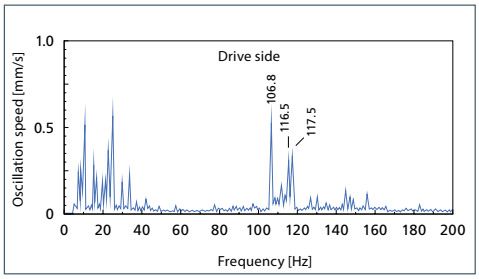
Fig. 6 Vibration measurement on the calender

In the vibration diagram (Fig. 6) the same two frequencies are clearly seen, which show the mass variations in the sheet (barring) as variations of 116.5 and 117.5 Hz. The comparison of these values with the rotation frequencies of the calender rolls shows the following result: The mass variation of 116.5 Hz is 12 times (the 12. harmonic) of the rotation frequency of calender roll 3, whilst the mass variation of 117.5 Hz is the 12. harmonic of the rotation frequency of calender roll 2.

From this it can be shown that both roll 3 and roll 2 have developed 12 flats. From this situation and from the calender roll circumference a barring with a spacing of approx. 18cm was calculated and confirmed in the sheet. Another interesting aspect: In the vibration measurement (Fig. 6) a peak at 106.8 Hz with a high oscillation velocity can be seen. This is the 11. harmonic of the rotation frequency of roll 3. Although this frequency dominates in the vibration, it does not show up in the sheet.

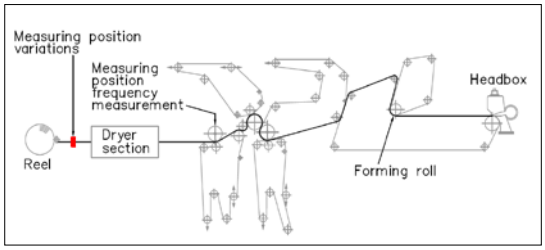
Fig. 7 Measuring Positions Case Study 2

On the occasion of a routine measurement of the sheet immediately after the dryer section on the front side (Fig. 7), a number of mass variations were recorded (Fig .8).

Firstly, the total vibration measurement of the 4. press measured on the top roll in the nip direction (measuring position in Fig. 7, Fig. 9), at 108.75 Hz showed an oscillation velocity of over 6 mm/s. This frequency was found to be the 16. harmonic of the rotation frequency of the venta roll of 6.7968 Hz, as confirmed by the synchronised time signal of this roll (Fig. 10).

The rotation diagram shows 16 peaks being the 16 flats on the surface of the venta roll. However, this disturbance factor is only one of the many peaks in both diagrams (Fig. 8 and 9), namely the one at 108.75 Hz. In this case it was only possible to recommend that the venta roll of the 4. press should be changed.

The forming roll of the twin wire former (Fig. 7) provided with its basic frequency (rotation frequency) of 4.82 Hz the starting point for all frequency values which were a multiple (an x. harmonic) of this basic frequency.
In the event of future deterioration of this roll during production causing severe mass variations in the sheet, the cause has now been identified.

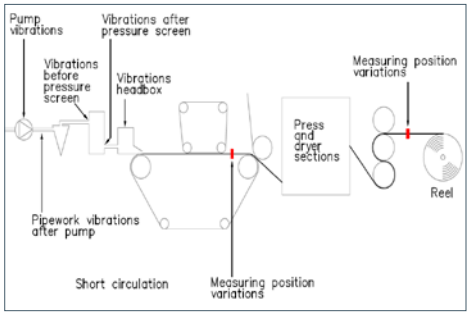
Fig. 11 Measuring Positions Case Study 3

The first measurement after the calender (Fig. 11) produced various mass variations in the range of 10-37 Hz including, however, a significant deviation at 18.5 Hz (Fig. 12).

During spot checks on the sheet in the direction of the headbox the same values kept reappearing. This applied also to the frequency pattern recorded on the bottom wire after the top wire former (measuring position in Fig. 11, Fig. 13).

This proved that the shake – irrespective of its frequency – was not the cause of the mass variation. Further investigation in the short circulation system all measurements showed up the 18.5 Hz oscillation.
Finally, a total vibration analysis in the axial direction on the stock mixing pump, which showed several harmonics of 18.5 Hz (measuring position in Fig. 11, Fig. 14) led to success – in combination with the rotation frequency of this stock pump which was found to be exactly 18.5 Hz.

These findings explain the presence and the constancy of the of the mass variations throughout the whole paper machine. The stock pump created a disturbing impulse in the stock flow once per revolution, which then showed up in the formation as a mass variation in the machine direction. When the stock pump was opened up, it was found to be heavily contaminated particularly on one blade. After the whole pump was thoroughly cleaned the barring at 18.5 Hz was immediately eliminated.

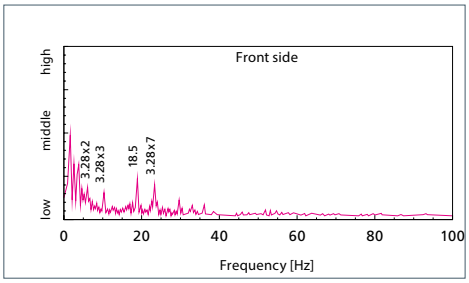
Fig. 13 Variations in the sheet after the twin wire former, Shake frequency 3.28 Hz, Stroke 7

A test carried out by increasing the shake frequency and stroke of the bottom wire and also by disconnecting the shake resulted in the measurements after the twin wire former showed increased deviations from the mean basis weight. Only the peaks at 18.5 Hz remained unchanged.

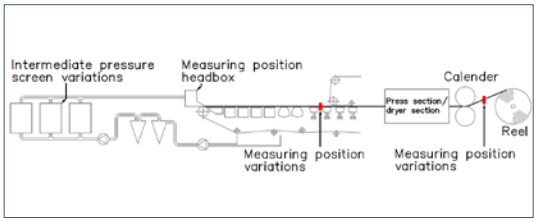
Fig. 15 Measuring Positions Case Study 4

The first measurement before the reel (Fig. 15) was taken at a fabric speed of 855.7 m/min and showed a dominant peak of mass variations at 41.13 Hz (Fig. 16). All further measurements in the direction of the headbox including the measurement between Vacufoils 1 and 2 showed this mass variation at the same frequency 41.13 Hz (Fig. 17).

Even a trial increase in the fabric speed to 868 m/min resulted in no change. This confirmed that the machine speed had no influence on the sheet barring.
Vibration measurements at the headbox, at the valves of the centrifugal screens and at the screens themselves repeatedly showed a frequency of 41.13 Hz. At the middle pressure screen, however, the highest amplitude in this critical frequency range was measured (Fig. 18).

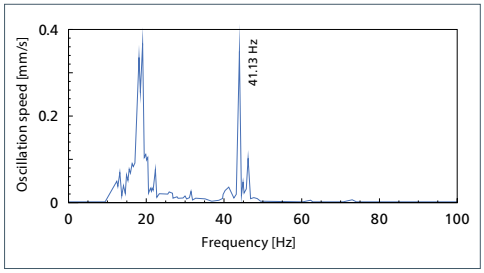
Fig. 18 Oscillations of intermediate pressure screen in radial direction top; wire speed 855.7 m/min

With a special computer program it is possible to relate disturbing frequencies to a bearing, when the type of bearing and the number of revolutions are known. With this technique it was possible to establish that the rotor bearing of the middle pressure screen was the cause of vibrations in the critical frequency range. Despite the fact that no damage to the rotor bearing was visible, a change was made. After installing the new rotor bearing in the pressure screen the disturbing frequency was no longer present as vibration and as mass variation.

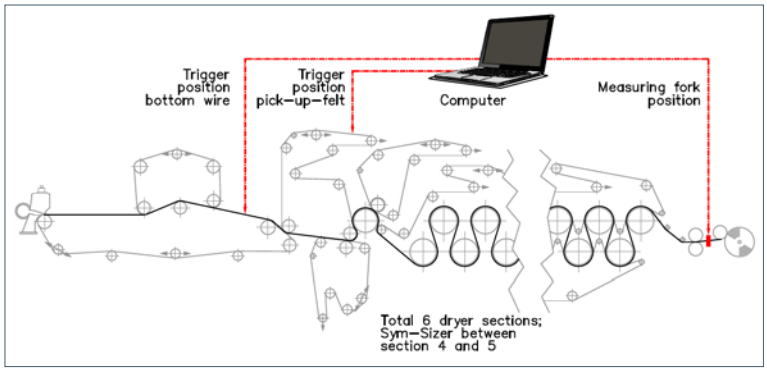
Fig. 19 Measuring Positions in the Paper Machine Case Study 5

Procedure and outcome of Heimbach measurements:
The ODIN measuring fork was installed on the drive side of the machine before the reel (Fig. 19). As the disturbance was at a frequency well below 1 Hz and in addition, regularly, but only very briefly peaked, a frequency analysis would have provided no information. Therefore time signals were examined.

Finally, the recently changed bottom forming fabric, which incidentally was also about 32 m long, was identified as the cause of the disturbance (see trigger position bottom fabric (Fig. 19).

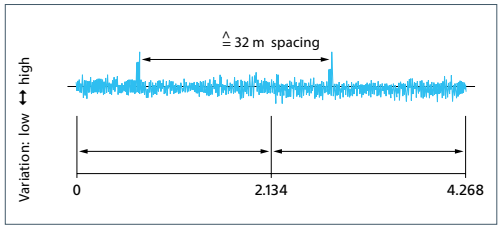
Fig. 20 Trigger signal bottom wire (forming section)

Fig. 20 shows the high peaks causing the disturbance in the sheet from the bottom fabric. For confirmation two revolutions of the fabric were checked (Fig. 20). The peaks occur clearly at a spacing of 32 m (one per revolution).

In this case a faulty bottom fabric was the cause of the marking in the sheet. This demonstrates that the "textile components" on the paper machine – that is both the fabrics and the press felts – can also create periodic mass variations.

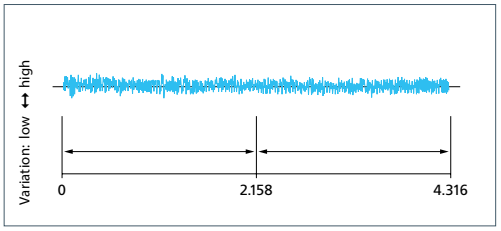
Fig. 21 Trigger signal pick-up felt

In comparison, Fig. 21 shows the synchronised measurement on the pick-up felt. There was no noticeable influence of the pick-up felt on the sheet, although at 32 m long it had originally been thought to be the cause.

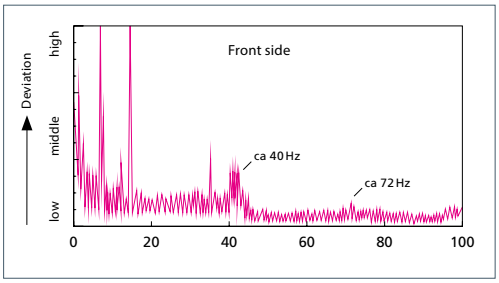
Fig. 22 Mass Variations before reel - Case Study 6

On this LWC machine relatively high MD mass variations were observed before the calender, particularly on the front side. The diagram in Fig. 22 shows a measurement with the ODIN measuring fork on the sheet before the reel-up. The peaks around 20 Hz are not relevant, as was later established; they have other causes, eg. from the calender rolls (thickness variations).
How-ever, the peaks around 40 Hz and 72 Hz, as shown in Fig. 22, are of importance for the mass variations. A relevant measurement on the drive side (Fig. 23) hardly shows any comparable peaks.

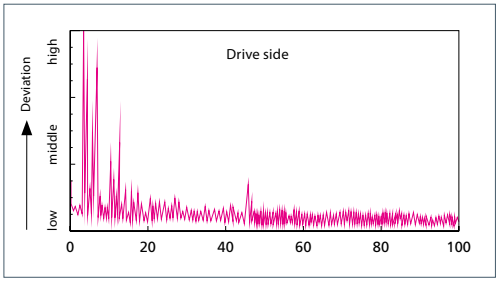
Fig. 23 Mass Variations before reel

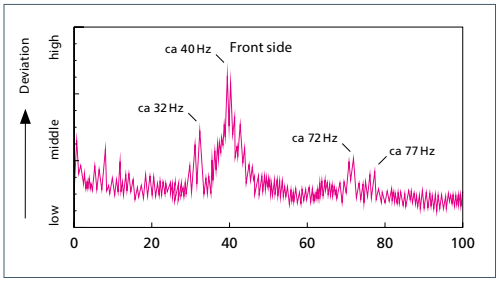
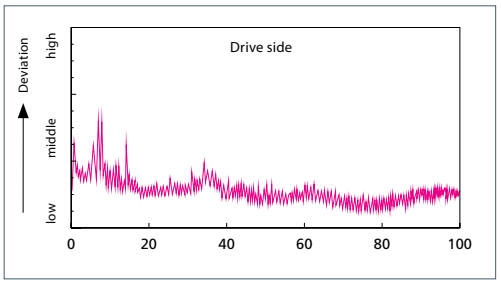
Further measurements were taken in steps from the reel towards the headbox, initially on front and drive side before the calender (Fig.24, 25). Particularly on the front side measurement the peaks at 40 and 72 Hz are more defined than at the reel – and here also the tendency was clear: the variations were significantly greater at the front side than at the drive side.

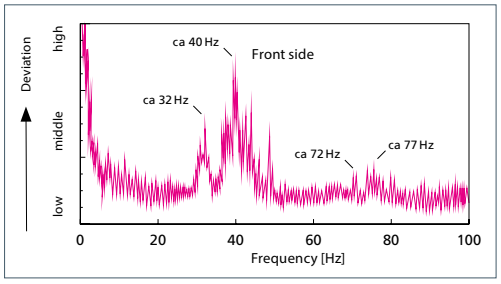
Fig. 26 Mass Variations after 2. Vacufoil section before top wire

The last measurement was on the front side of the forming fabric before the top former and immediately after the 2. Vacufoil section (Fig. 26). Despite the high level of water removal at this point the curve shows a close comparison with the signals from the finished sheet (see Fig. 22 + 24). As a result the suspicion hardened that the cause of the disturbance was not to be found here in the forming section but rather in the approach flow system.

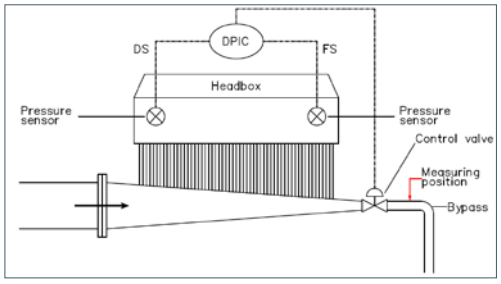
Fig. 27 Schematic Layout of pressure sensors and backflow line of the headbox

The subsequent measurements on pumps, screens etc. provided no clues; the pattern of the disturbance would also not have been typical for such a source. Also vibration measurements on the backflow line of the headbox just after the control valve (Fig. 27 + 28) did not provide clear agreement.

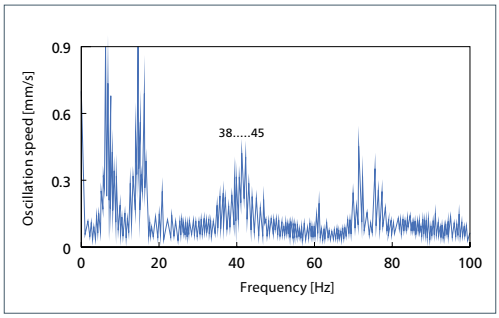
Fig. 28 Vibrations on the backflow line of the headbox

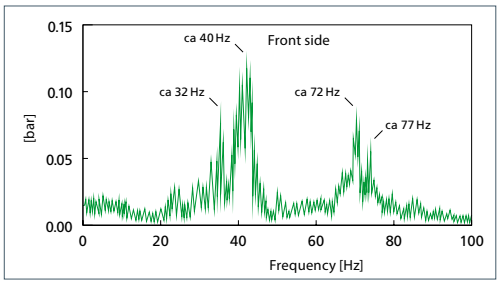
Fig. 29 FFT pressure signal at headbox before change of control valve

The machine measured in this example has pressure sensors installed at front side and drive side of the headbox – and here the breakthrough was made: a frequency analysis (FFT) of the signal of the front side pressure sensor supplied the unambiguous agreement (Fig. 29) with the measurement signals on the finished sheet (see Fig. 24). The stock entry was on the drive side and the stock exit on the front side – where the control valve was positioned.

As a result of this diagnosis Heimbach recommended the replacement of this valve with an improved version. Proof of the validity of this advice is seen in the diagrams in Fig. 30: frequency analysis of the front side pressure sensor, and Fig.31: measurement of the sheet with the ODIN measuring fork on the front side before the calender – both after changing the valve. Also the peaks in the sensor pressure signal and also in the MD mass profile have been eliminated. The measuring and diagnostic effort involved in this case study was very comprehensive, but the efforts were more than rewarded by the discovery of a “confusing” cause.
