Heimbach-TASK

Catalogue of Services

task.
Technical Assistance,
Service and Know-how

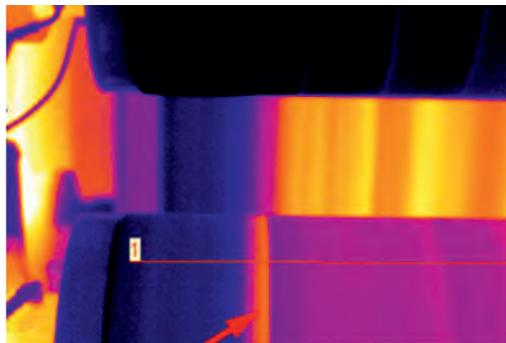
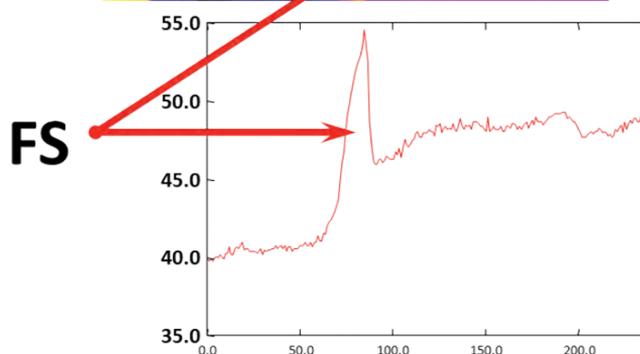
Thermography allows contactless registering and subsequent visual presentation of temperatures. The camera measures the infrared radiation emitted from an object and allows the surface temperature to be rendered in color. Surfaces with little emission, such as bare metals, reflect significantly more heat radiation than they emit and therefore are not suitable for capturing by an IR camera/sensor.

There is often a connection between temperature and moisture profile of the paper sheet, particularly in the dryer section.

As a rule, starting at the reel spool, images are taken, tracking the error in the machine. In the area of the forming section no temperature difference between high and low dryer contents is detectable most of the time, as fibres and water still have the same temperatures at that point.

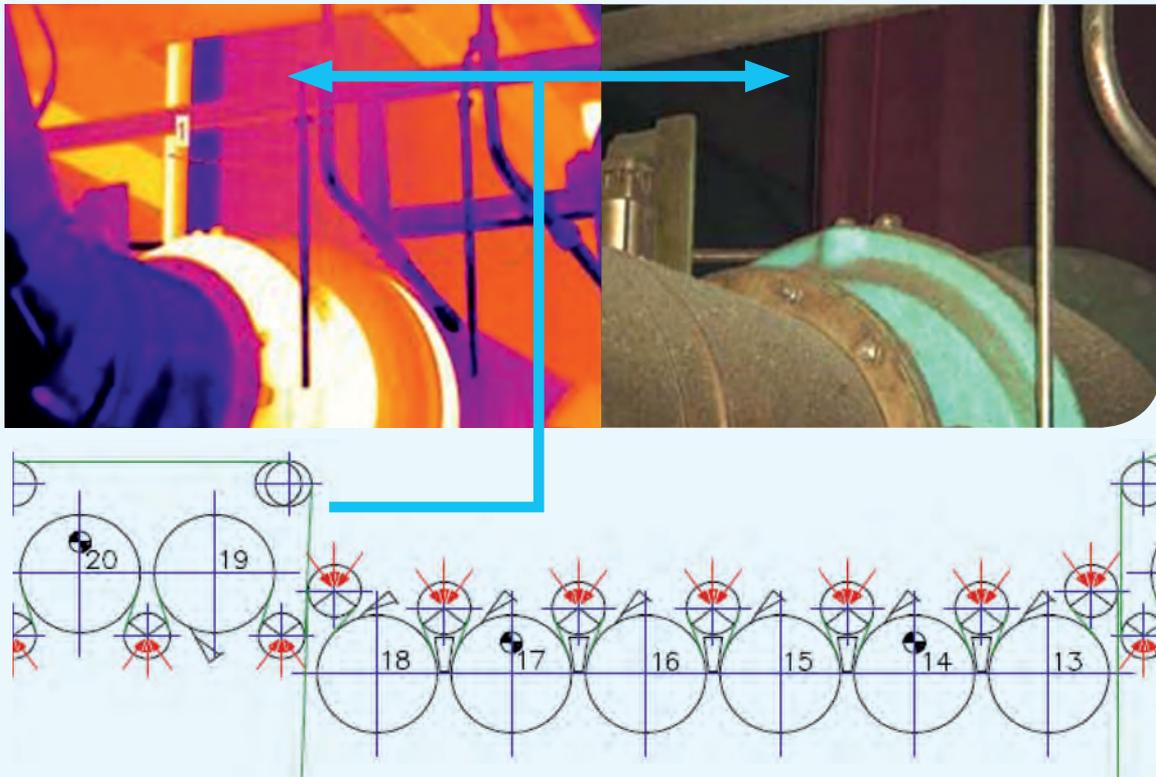
A customer complained about increased moisture at the sheet edge at the front side, which forced him to reduce the machine speed by up to 50 ml/min for some grades. Heimbach-TASK carried out a thermography measurement, starting at the reel-up. The wet edge was clearly visible up to cylinder 19. Before this cylinder the temperature was distributed evenly across the sheet width.

Then the clothing was checked more closely, and the cause of the wet edge of the sheet could be determined. The dryer fabric, which ran in the slalom group from cylinder 19 onwards, was contaminated with oil at the front side edge. The fabric lost its tension and therefore also its pressure in the oily area, compared to the rest of the sheet width. In addition to this the air permeability of the fabric was different because of the oil contamination.

During the next machine shut the oil leak was found and sealed. Furthermore, the cylinders and vac rolls were cleaned at the front side in order to remove the oil residue. After that a new dryer fabric was installed and the machine was re-started. After the start-up phase no wet streak was detectable. Thus, the machine achieved its full production speed once again. In the following month this speed increase meant increased production of 100s of tons. Moreover, the lifetime of the dryer fabric was extended considerably.

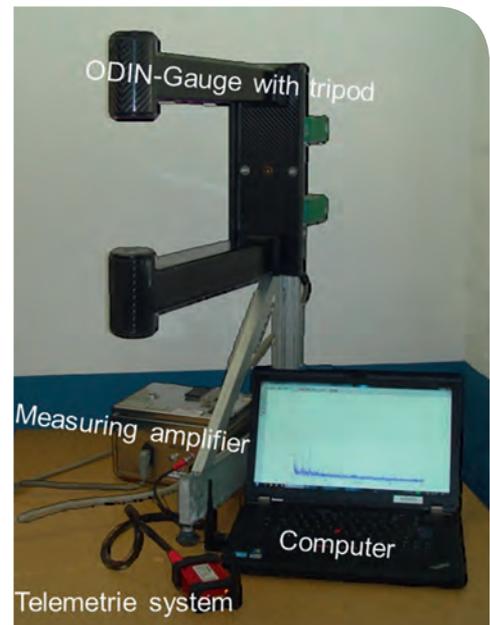
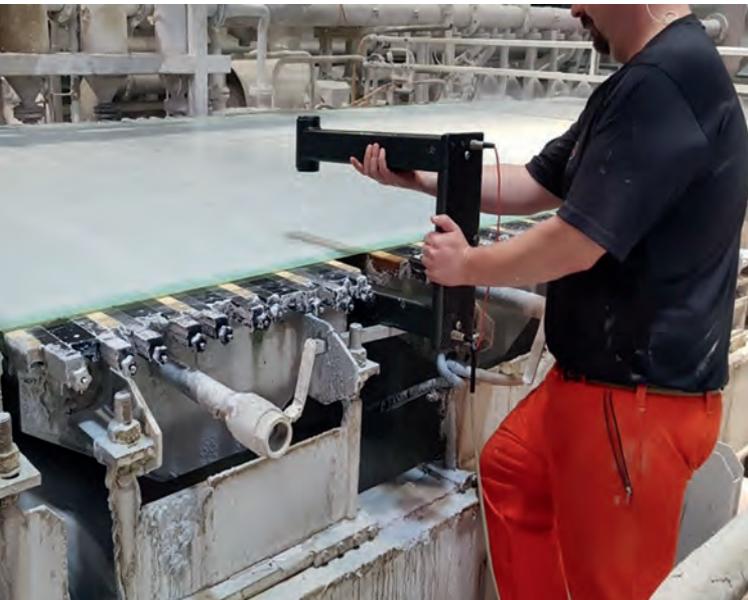
The term “barring” refers to markings that occur in the paper sheet in cross direction. Mostly it means variations in mass. Often these mass variations cannot be detected by the online diagnostic systems because their scanning rates are generally too low, even during point measurement. This is why we measure such mass variations with our mobile ODIN system (scanning rate 3000 Hz).

These series of measurement start before the roll-up. Subsequent measurements are carried out at all accessible positions in order to localize the root cause.

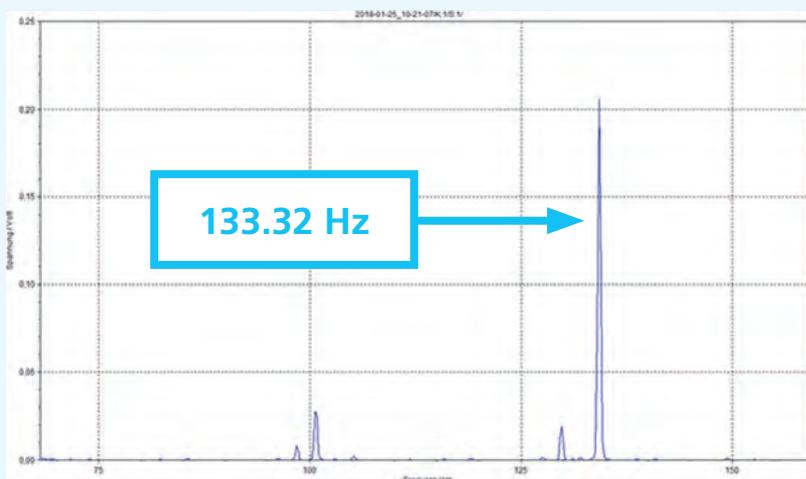
By using the ODIN fork barring was detected immediately before the reel-up (133.32 Hz). Following that it was also found in front of the calendar, in front of the size press and immediately behind the headbox. Therefore, the likelihood of the causal factor being found in the approach flow system was very high. The TASK team followed the stock against the flow direction. Before the headbox a pulsation damper was situated, which, however, could be excluded as causal factor: It does not contain any rotating parts and is therefore unable to cause any interfering frequencies. In front of the pulsation damper there was a pressure screen. Here a rotating frequency of exactly 33.33 Hz was measured.

The technical specifications of the vertical screen showed that the rotor had four blades. This meant: Rotating frequency (33.33 Hz) x 4 blades = 133.32 Hz!

A customer complained about barring in the paper sheet that repeated every 50 mm. The scanning rate of the on-line scanning equipment (100 Hz) is able to measure variations, but in this case only every fourth. This could have led to the conclusion that an interfering frequency was the cause, although here this does not determine clearly the root cause of the problem. The scanning rate of 100 Hz, at a machine speed of 1200 m/min, means that the scanning equipment achieves a measuring point at every 200 mm only. The ODIN measuring system scans the sheet at 3000 Hz, which, at this speed, means: Every 6.6 mm a measuring point is achieved. Moreover, this measuring system is mobile and therefore able to localize the original source of the problem.

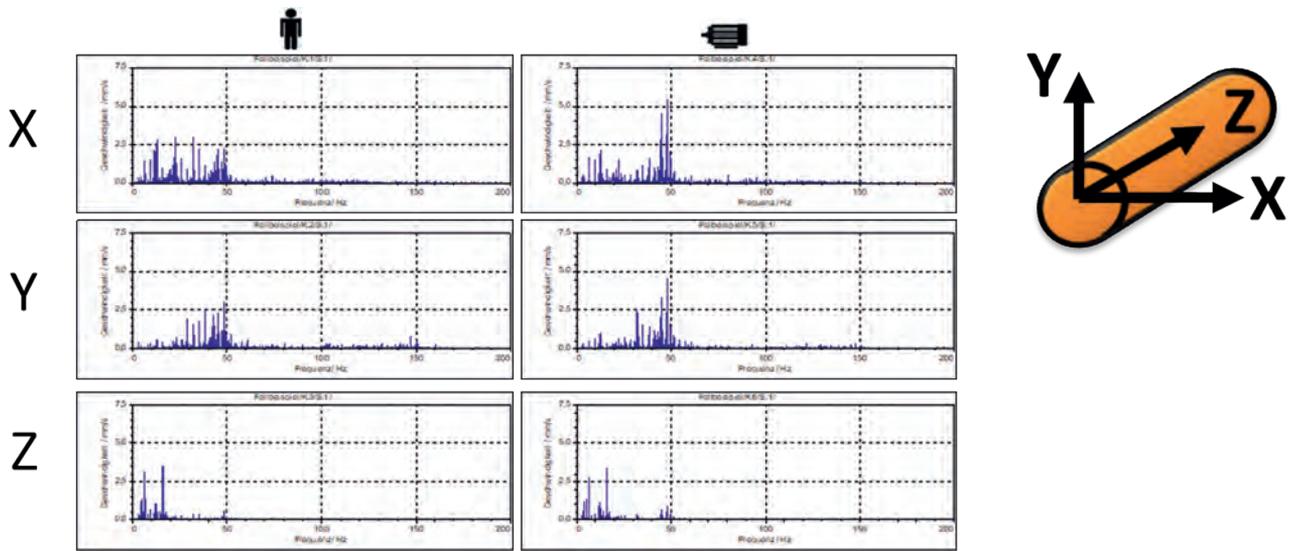
The triaxial acceleration sensors used by us pick up the horizontal, vertical and axial movements of a rotating component at the same time. The raw data (vibration measurement) of the acceleration sensors are transmitted to the computer via telemetry and are processed by its software.

Thus, a graphic representation of the FFT is possible (see diagram). The acceleration sensors in the press section are primarily attached to the bearing housings of the rolls. Every measurement takes place simultaneously at the front side and the drive side of the respective roll.

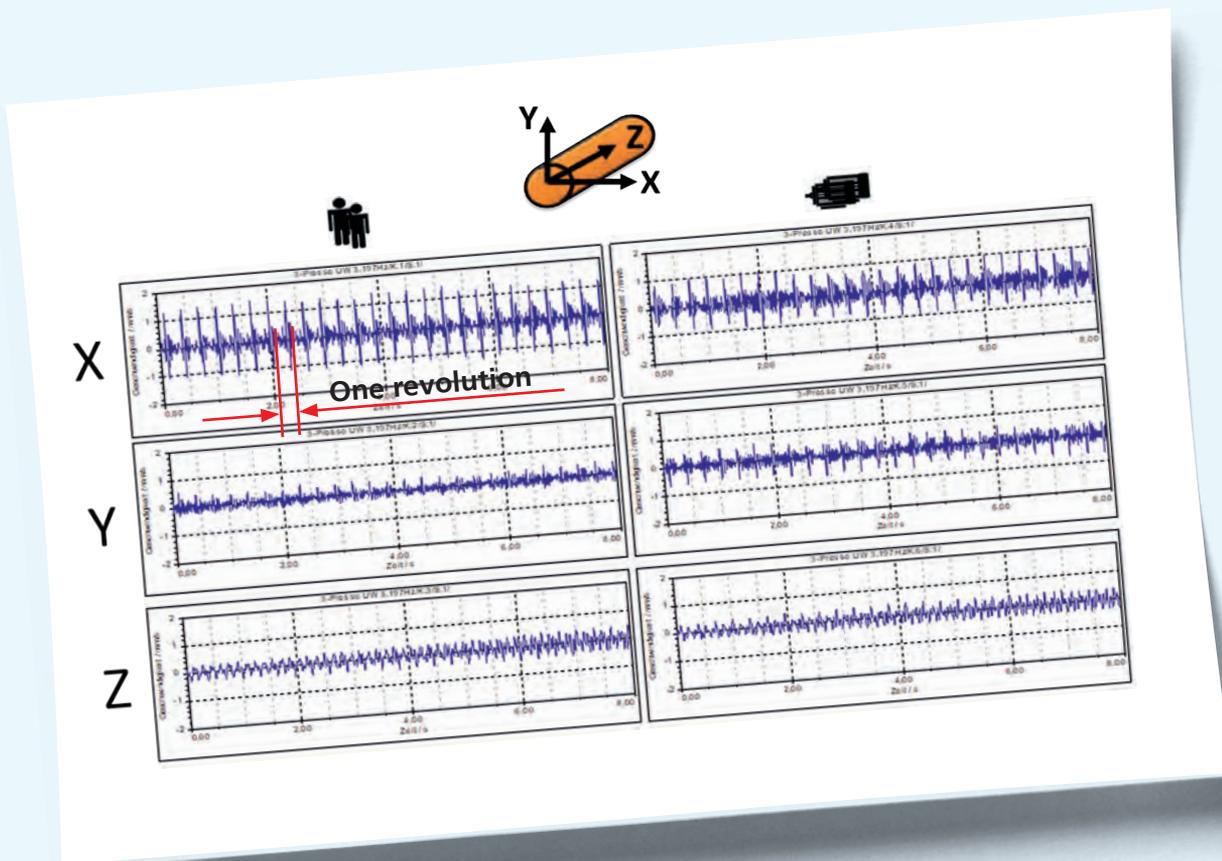
A customer noticed very intensive vibration in his press section but was unable to localize the root cause. We carried out a vibration measurement. We put the acceleration sensors one after the other on the bearing housings and recorded the vibration velocities of each press roll in the press section. Additionally, the rotational frequencies of the rolls, by means of IR sensor, were measured in order to match the timings of the interference signals to the rotating parts of the machine.

The time signal of the press belt in the shoe press showed clearly that once per rotation the belt swung/shifted horizontally. This led to extremely strong vibrations in the entire press section. The next day the belt was removed and checked. It was damaged on the inside over an approximately 30cm long area, which made the press section to vibrate once per rotation.

After examining the shoe, a new press belt was installed. During re-measuring – with the new belt – no significant vibrations were detectable.

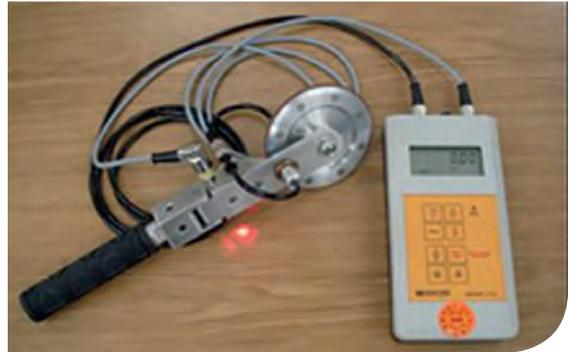
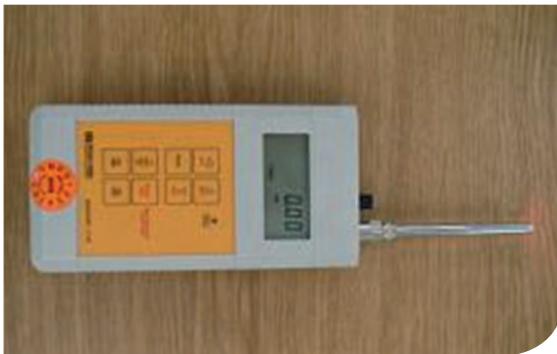
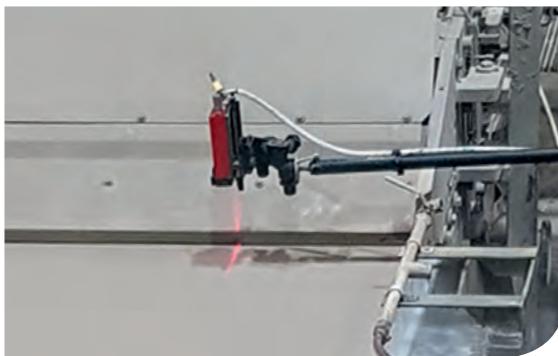
Speed wheel:

In order to determine surface speeds of rolls, fabrics, felts, etc., an inspection using the highly accurate length and speed measuring wheel is sufficient. The measuring wheel used by TASK contains a special rubber cover which ensures that there is hardly any slippage occurring between measuring wheel and material (such as wet fabric).

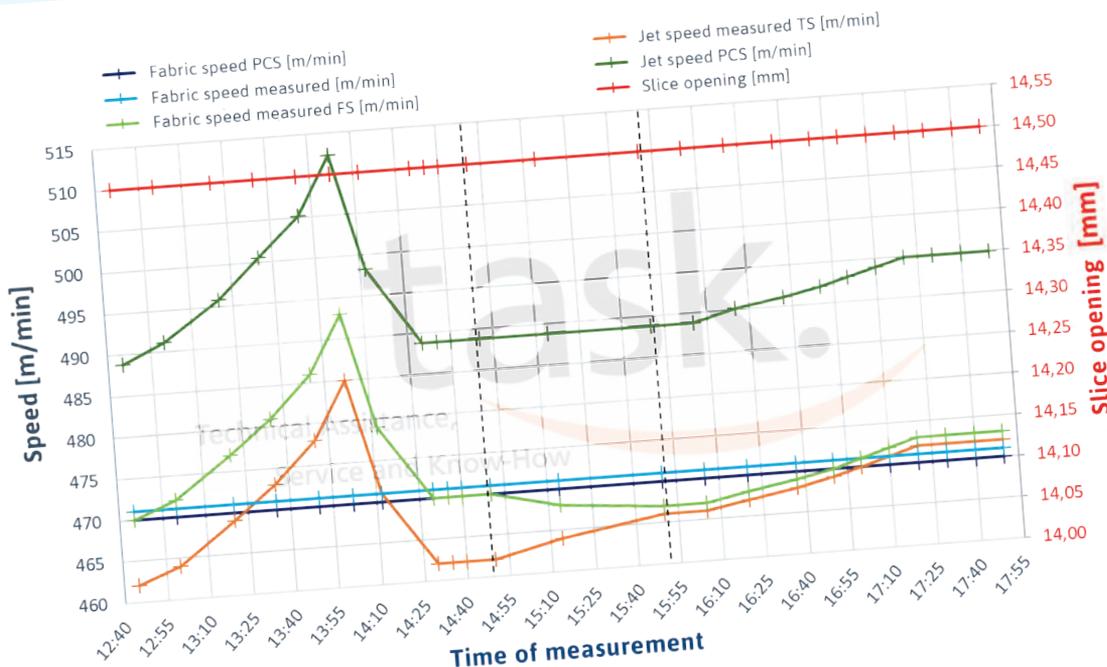
After we had measured the speeds of clothing and rolls in the forming and press section, we set up two lasers in order to measure the jet velocity in parallel on front side and drive side. It became obvious very quickly that the jet on the drive side was approx. 8 m/min slower than on the front side. In addition, the jet on the front side was 19 m/min slower than shown in the PCS.

As a test we changed the jet velocity in the PCS in order to see whether the measurement would show the same result. This worked perfectly (see diagram: 12.40-14.30 hours) and meant that the control of the

headbox pump and the corresponding programming in the PCS were functioning. At each setting the difference between the jet velocity shown and measured was identical. We then looked for the cause of the variation between front side and drive side. There had to be a pressure difference in the headbox which could in all probability only come from the cross-flow spreader. And that is what we found. The return flow was too restricted. We opened this return flow slowly, and the jet velocities of front side and drive side started to converge. When the return flow was opened fully the difference between front side and drive side was only 1 m/min (diagram: 14.50-15.50). Subsequently we increased the jet speed so that the customer was once again able to produce even paper quality. Then (from 18.00 onwards) we changed the slice opening of the headbox incrementally in order to see whether the jet speed remained constant, which is what it did. Therefore, by the end of the day we had established: the customer only needs to program an offset (22 m/min) and the correct jet speed would be displayed in the PCS.

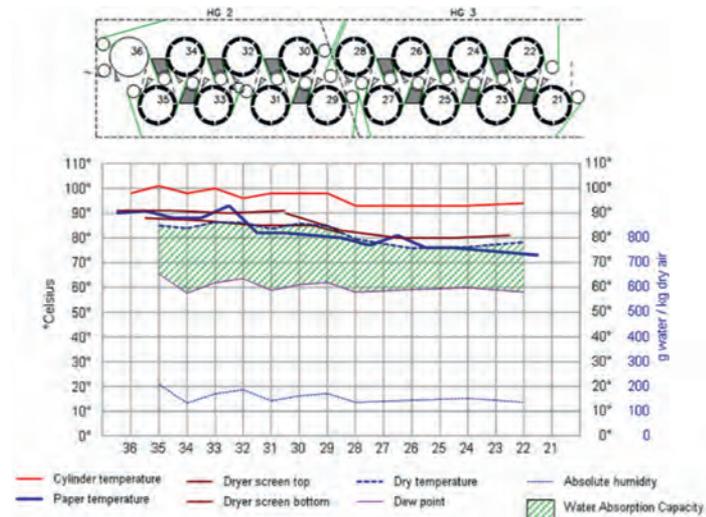
The objective of a dryer section analysis is to check the conditions inside the dryer hood by measuring pocket air conditions and the surface temperatures of clothing, paper sheet and drying cylinders. The dew point as well as the relative and absolute moisture are worked out from dry and moist air temperature.

To achieve this, measurements are taken at approximately 50cm from the front side of the paper sheet. Measuring the cylinder temperatures provides information about the course of the heat curve in terms of the necessary uniformity of the temperature increase as well as about potential irregularities (such as “flooded” cylinders). It also allows statements regarding superfluous warming of the clothing in a slalom group by e.g. inner cylinders. It is necessary to keep an eye on the temperature of the paper sheet in order to avoid problems such as fibre deposits at the first few drying cylinders. Generally, a uniform increase of the cylinder temperatures and therefore also those of the paper sheet should happen. Too much of a difference between the two will lead to fibre plucking and even to complete rupture of the paper sheet. In the diagram you can see dry temperature, dew point and absolute air humidity. The difference between dry temperature and dew point is marked by hatching. The larger the difference, the higher the water absorbency of the air and the faster the moisture can be evacuated.

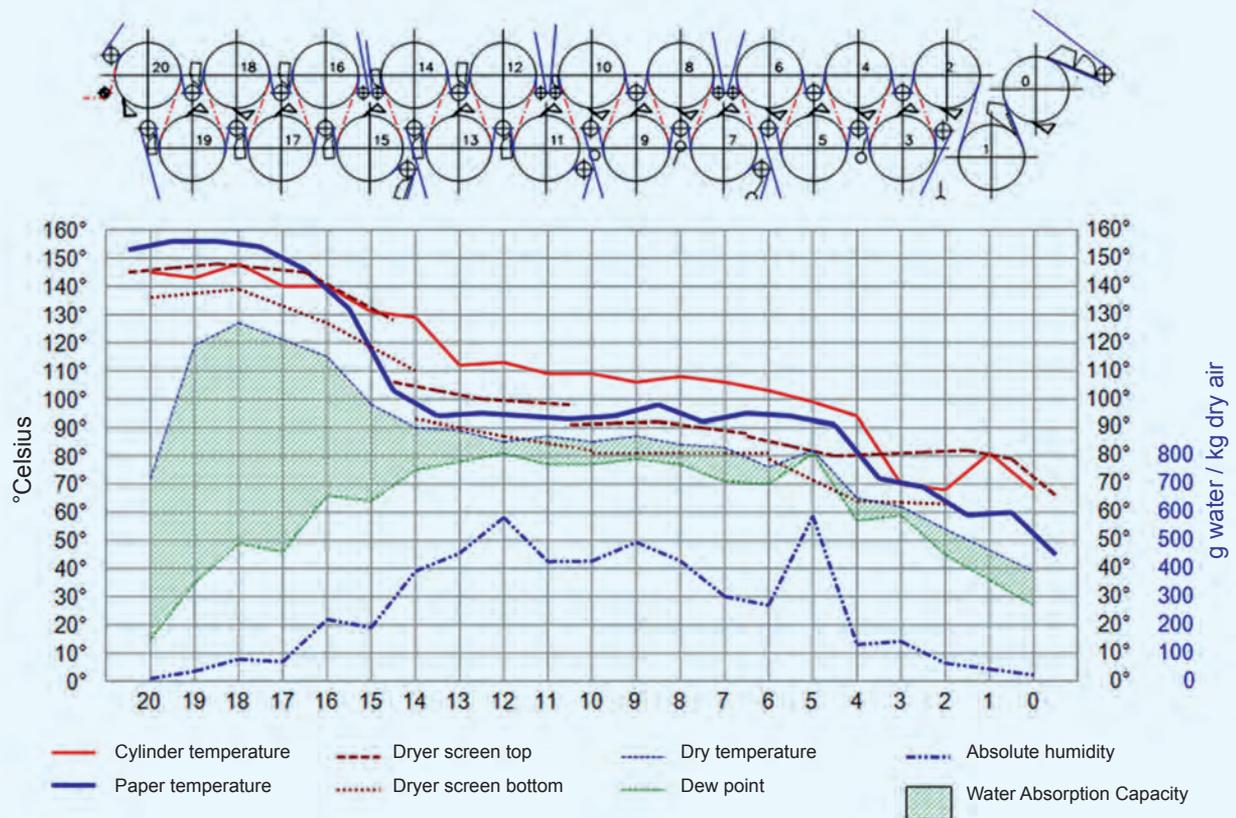
A customer requested a dryer section analysis because he wanted to optimise his machine in terms of speed. He specifically asked for this measurement because he himself had identified the dryer section as a bottleneck area within his process. The machine to be examined was a decor paper machine: This was evident by measurement value display of the dryer section, which indicated a higher paper temperature than cylinder temperature from cylinder 16 onwards.

We found that the dryer section was running at maximum capacity, meaning that the water absorbency of the air was under 10°C for the first 13 cylinders. Additionally, the clothing temperatures were very close to the dew point; for cylinder 5 even below. This meant there was great danger of condensation of the water vapor in the pocket air to reach the clothing and consequently to remoisten the paper. However, there was an area in the hood where enough hot air intake was available (Cyl. 15-20). Underneath cylinders 0-12 we found an “undercurrent” which clearly was not very efficient. Unfortunately, this undercurrent did not reach the cylinder pockets where it was needed, because of a large extent it moved past the paper sheet on both front and drive side and ended up as exhaust air. When the hot air of the undercurrent is directed straight into the cylinder pockets of the first 13 cylinders the water absorbency is increased enormously. In this way the machine speed can be increased without increasing energy costs for the ventilation of the pockets. Therefore, our recommendation is: “Replace undercurrent with efficient pocket ventilation”. This is achieved very well by using blow pipes or blow doctors.

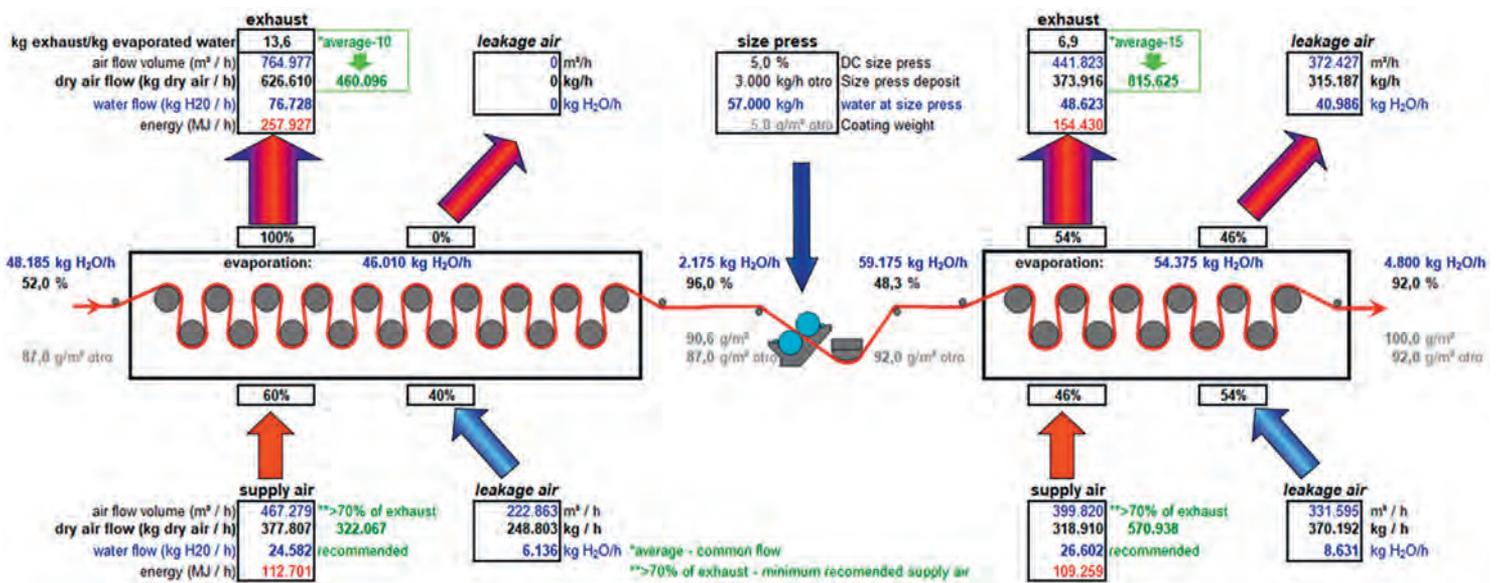
When balancing a dryer hood the quantity of water to be evacuated is calculated. However, to be able to evacuate it an appropriate air volume is needed. Experience shows on average that this air volume is around 10 kgs dry air per 1 kg water (pre- dryer). Depending on paper grade and production output the evaporation rates vary. Therefore, a hood balance should be performed at the production output that yields the highest evaporation rates in the dryer section.

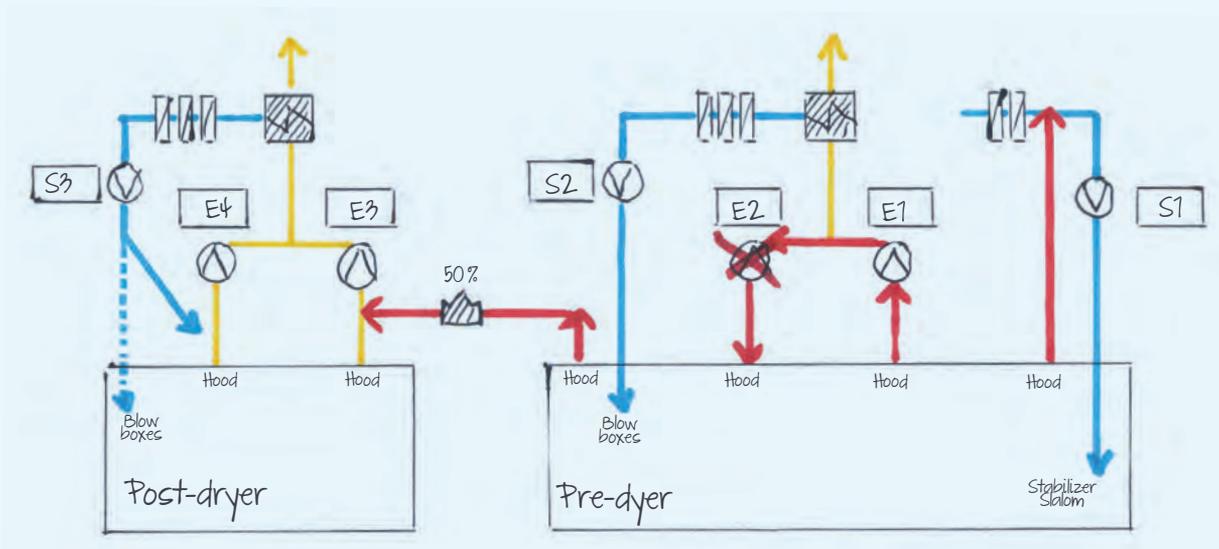
One of the exhaust ventilators of the pre-dryer section turned in the wrong direction. How was this possible? The drive belt for power transmission from motor to fan was torn. The airflow, evacuated by the other exhaust air ventilator, pushed it in the wrong direction. This meant the air was not transported outside but was returned into the dryer hood. The hot, moist air was circled around rather than evacuated.

This effect was intensified by the design of the exhaust duct, which impeded air extraction. Therefore, the heat exchanger did no longer work efficiently, and the hot air intake became noticeably colder. As a result, the paper sheet dried more slowly, and the customer was forced to reduce the machine speed considerably. And this with increased energy use! Matters were made worse by two very large holes in the air intake duct of the post-dryer,

The drive belt of the exhaust ventilator of the pre-dryer was replaced and the holes in the air intake duct of the post dryer were closed. After this short shut time it was possible once again to start up the machine at its usual production speed.

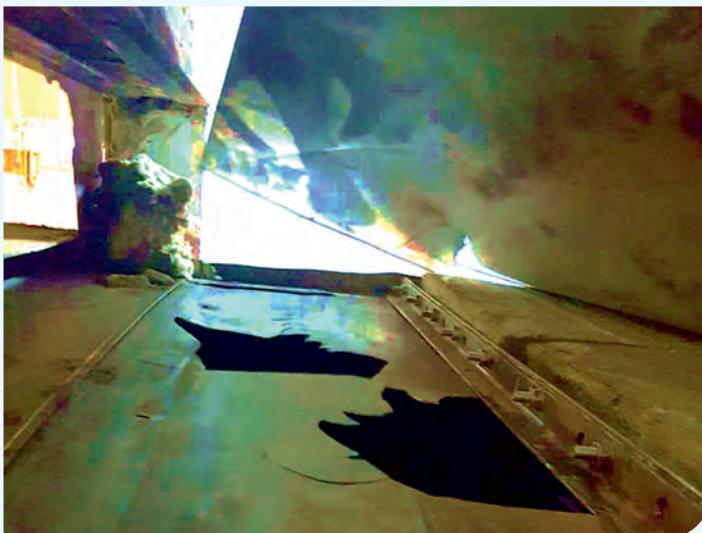
behind the air intake fan. This meant that a large part of the heated, dry air intake was evacuated into the hall.

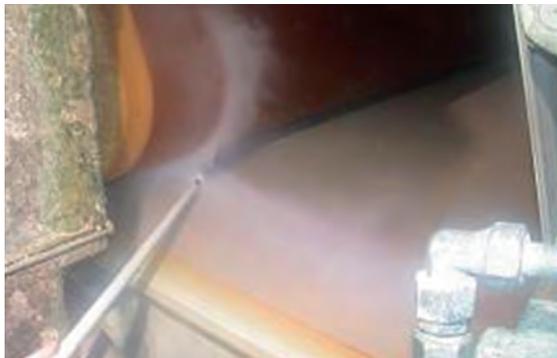
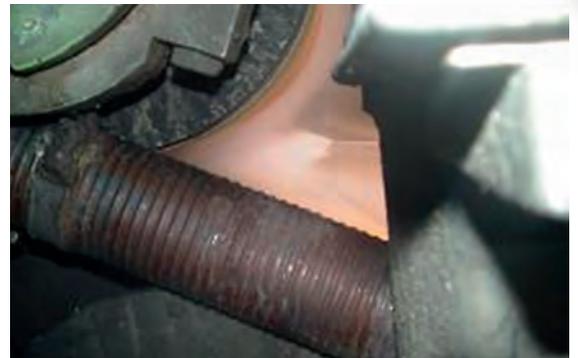
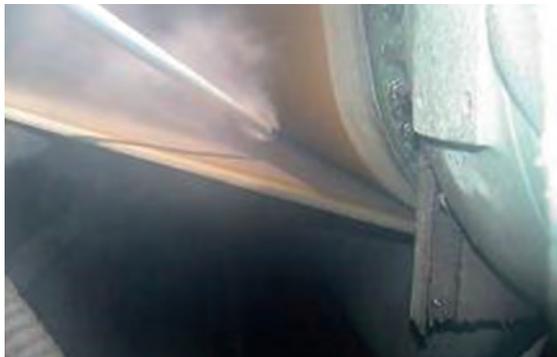
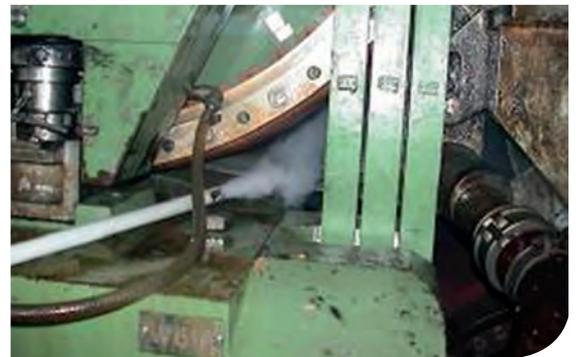
Visualization of air flows is achieved by introducing mist plus photo and video documentation of the now visible air flows. In order to find root causes for uncontrolled, or unwanted air flows, for example, measurements of the air speeds are conducted.

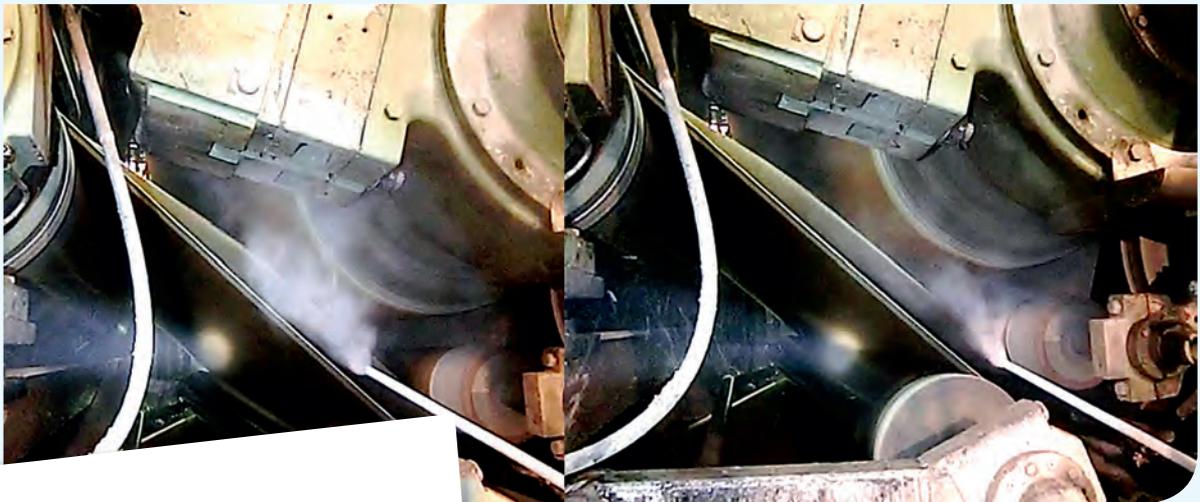
In order to visualize this belief and therefore also to prove we then made the airflows visible with the aid of a misting machine and documented them with a video camera. It became clearly visible that air flowed between felt and paper sheet in the direction of the front side.

This air was drawn back into the machine, around the paper edge, over the sheet, and thus produced the problematic edge fluttering. The following measures to resolve the problem were suggested:

- 1)** Install an air deflector directly next to the felt lead roll and thus direct the airflow against machine direction.
- 2)** Install a "suction tube" under the felt in order to suck the airflow through the felt and at the same time keep the sheet on the felt.

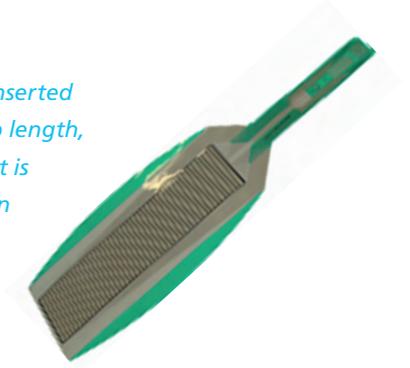
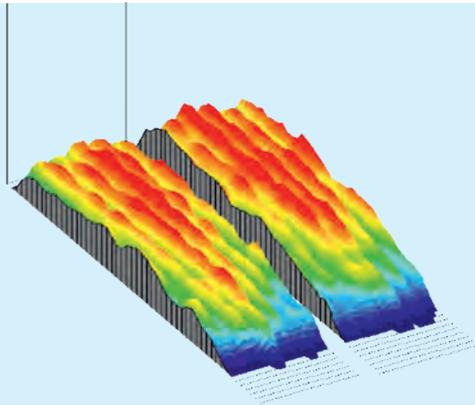
In order to examine presses Heimbach uses special single sensors that are inserted next to each other in the nip. Force and contact area are measured and nip length, pressure distribution and line force calculated from that. This measurement is often repeated with different settings in order to achieve clear information about force distributions and the related nip lengths.

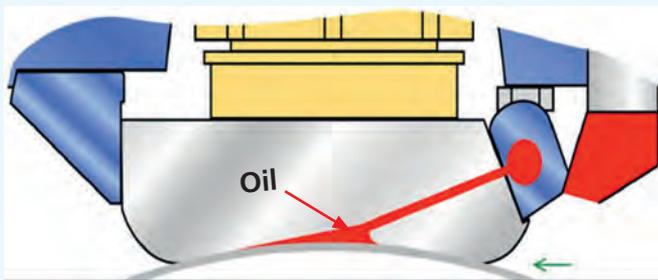
The shoe in this press was interrupted in the running direction of the machine. At this point pressure was created with oil (red in the diagram); this means the lubricant for the inside of the press belt is introduced directly into the shoe during operation. However, the oil could not be introduced in shut mode, which also concerned the nip profile measurement, because the press belt would have been saturated with oil.

A customer complained about a wet streak in the sheet having occurred for approx. 2 weeks. The root cause could not be explained. The Heimbach HOME Service measurements showed increased water content in the corresponding place of a felt. This felt only ran through the nip of a shoe press. And it was this shoe press TASK were asked to investigate.

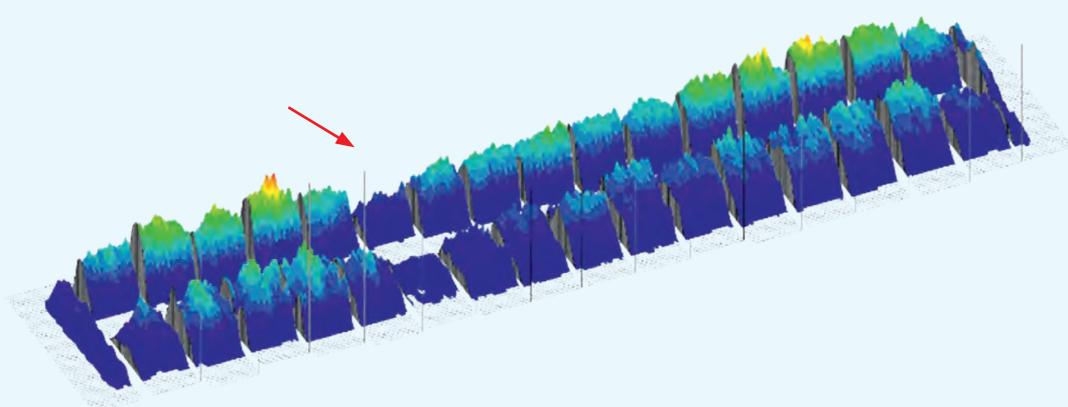
Therefore, the measurement was conducted without oil pressure between shoe and belt. Subsequently the relevant calibration data were added to it and evaluated. The force distribution in CD showed conclusively that hardly any force arrived in one location in the nip. The 3D representation of this force distribution illustrates this visually.

Therefore, it became clear that the wet streak in the sheet originated in the shoe press. In order to gain more accurate information, the customer had the press removed and checked by the manufacturer. It emerged that the shoe was warped. The customer suspected that a broken felt in the PM was responsible for the deformation of the shoe in this way. The pressure pistons of the shoe press were checked, and a new shoe was fitted. Moreover, a new felt was installed and the machine was restarted. The wet streak that had been visible before in paper and felt had disappeared.

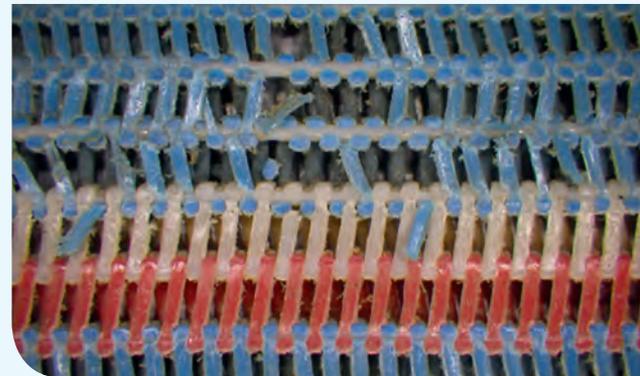
The dryer fabric in question – an unfilled spiral fabric – had been fitted in the third drying group. In the second drying group there were cleaning modules, on which we concentrated as a first step. We suspected that the spray mist from these cleaning modules was carried by the dryer fabric and was therefore transported to the guiding rolls. But the question remained: Why only those three guiding rolls? When the paper sheet broke we found the solution to the puzzle. Every time a sheet broke the cleaning modules switched on automatically. However, the collection tray of the upper cleaner was defective and the water ran directly onto the lower cylinder of the third drying group. This is why the spiral fabric distributed the water onto the three lead rolls in question, which, as a result, corroded much more quickly than usual. The customer repaired the collection tray, fitted three new lead rolls, and the dryer fabric achieved its planned lifetime once again.

A dryer fabric had to be exchanged every three weeks because it had abraded or even almost fallen apart across the entire surface area. The customer knew that the culprits were three corroded lead rolls. However, for us the question was why it was only those three lead rolls that were corroded in the entire dryer section.
