Heimbach-TASK

Catalogue of Services

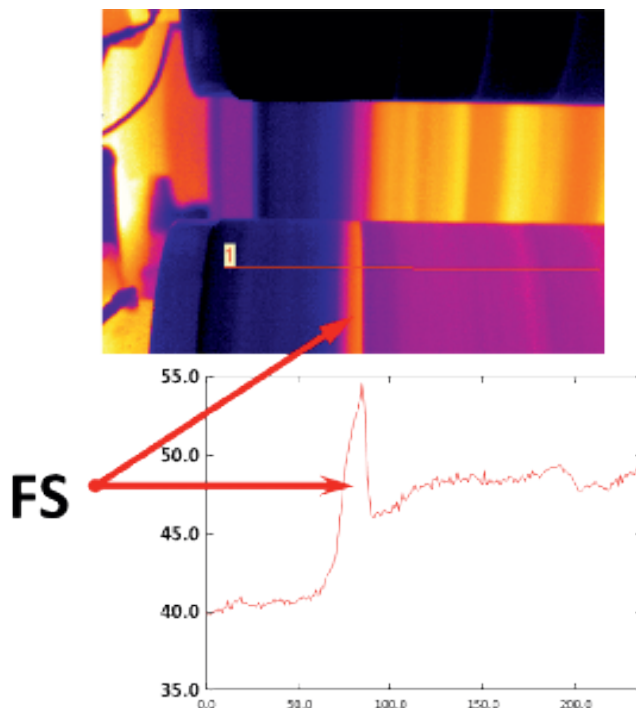
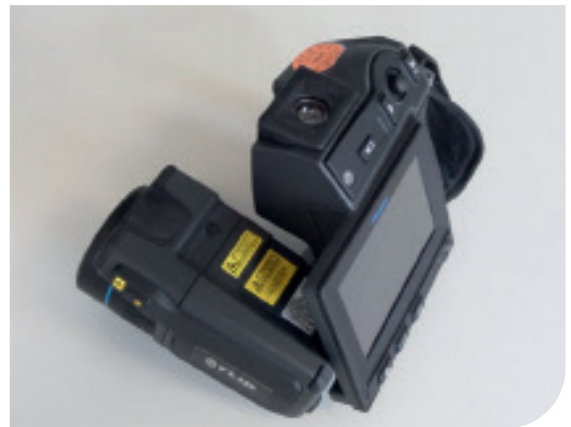
Thermography allows contactless registering and subsequent visual presentation of temperatures. The camera measures the infrared radiation emitted from an object and allows the surface temperature to be rendered in color. Surfaces with little emission, such as bare metals, reflect significantly more heat radiation than they emit and therefore are not suitable for capturing by an IR camera/sensor.

As a rule, starting at the reel spool, images are taken, tracking the error in the machine. In the area of the forming section no temperature difference between high and low dryer contents is detectable most of the time, as fibres and water still have the same temperatures at that point.

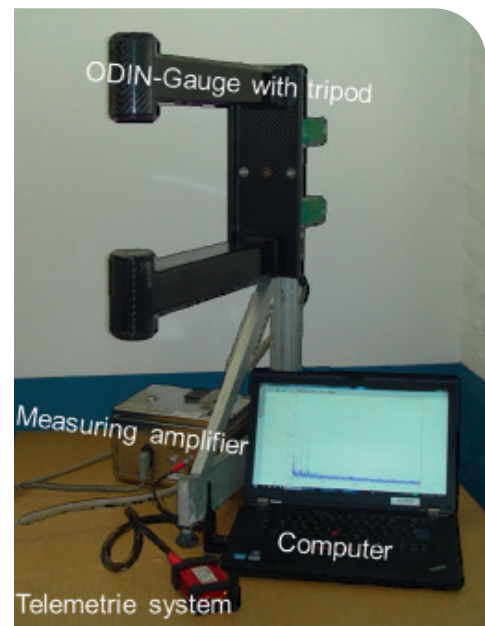
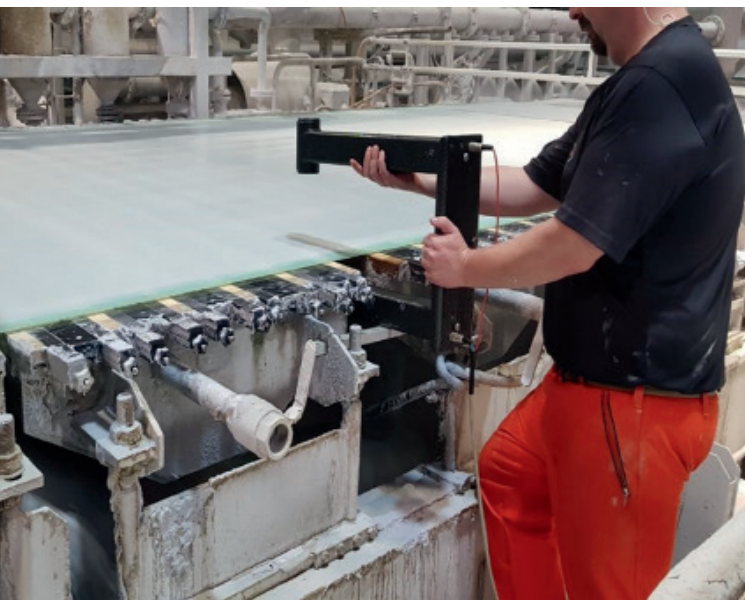
The term “barring” refers to markings that occur in the paper sheet in cross direction. Mostly it means variations in mass. Often these mass variations cannot be detected by the online diagnostic systems because their scanning rates are generally too low, even during point measurement. This is why we measure such mass variations with our mobile ODIN system (scanning rate 3000 Hz).

These series of measurement start before the roll-up. Subsequent measurements are carried out at all accessible positions in order to localize the root cause.

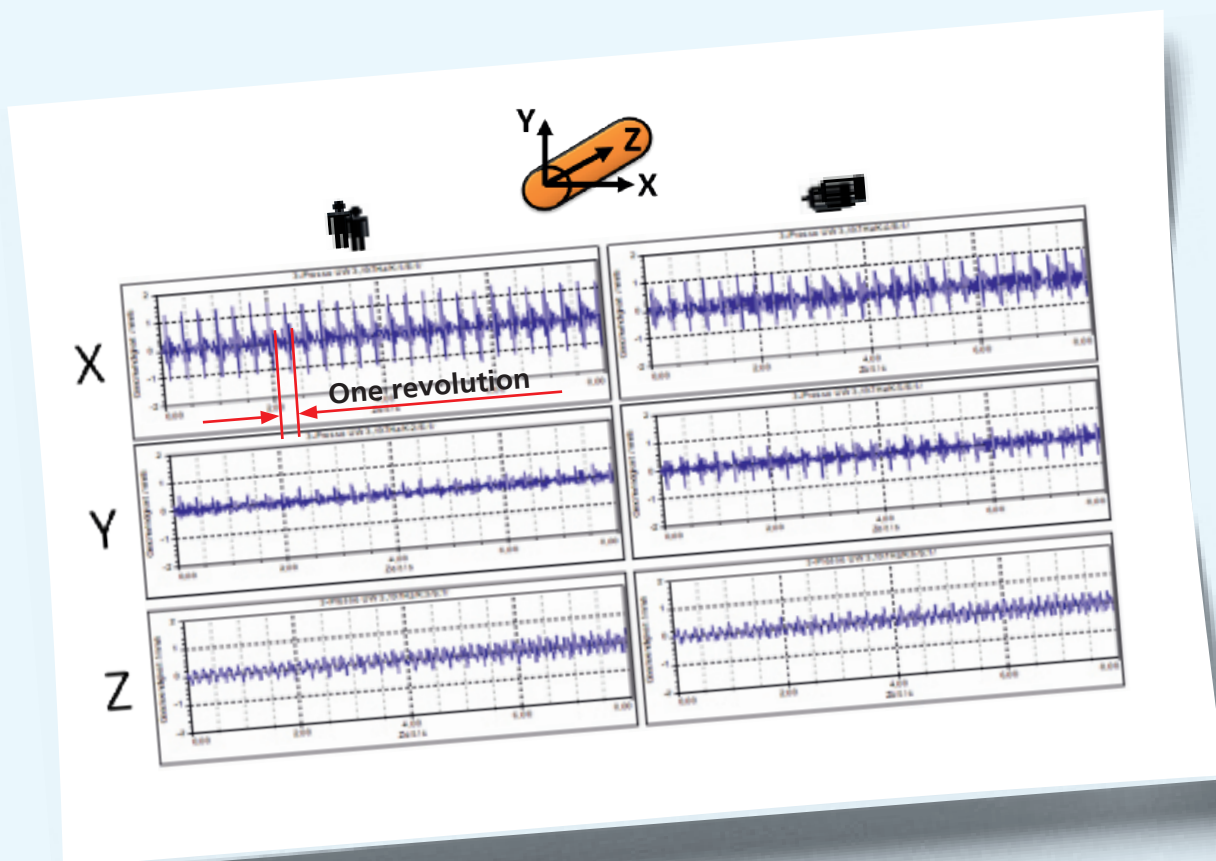
A customer noticed very intensive vibration in his press section but was unable to localize the root cause. We carried out a vibration measurement. We put the acceleration sensors one after the other on the bearing housings and recorded the vibration velocities of each press roll in the press section. Additionally, the rotational frequencies of the rolls, by means of IR sensor, were measured in order to match the timings of the interference signals to the rotating parts of the machine.

The time signal of the press belt in the shoe press showed clearly that once per rotation the belt swung/shifted horizontally. This led to extremely strong vibrations in the entire press section. The next day the belt was removed and checked. It was damaged on the inside over an approximately 30cm long area, which made the press section to vibrate once per rotation.

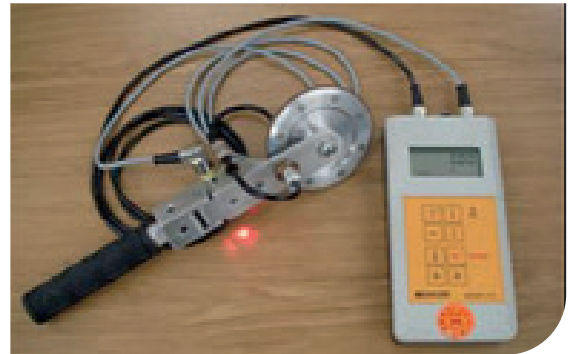
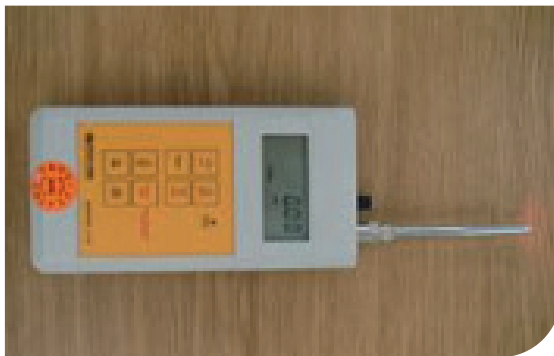
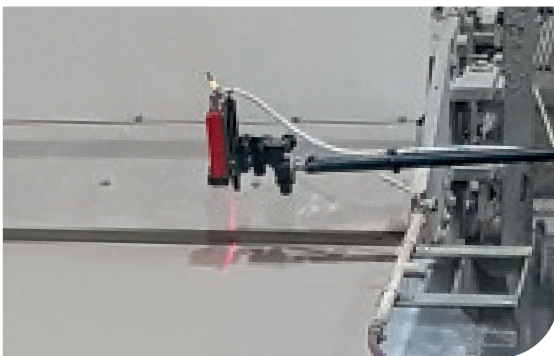
In order to determine surface speeds of rolls, fabrics, felts, etc., an inspection using the highly accurate length and speed measuring wheel is sufficient. The measuring wheel used by TASK contains a special rubber cover which ensures that there is hardly any slippage occurring between measuring wheel and material (such as wet fabric).

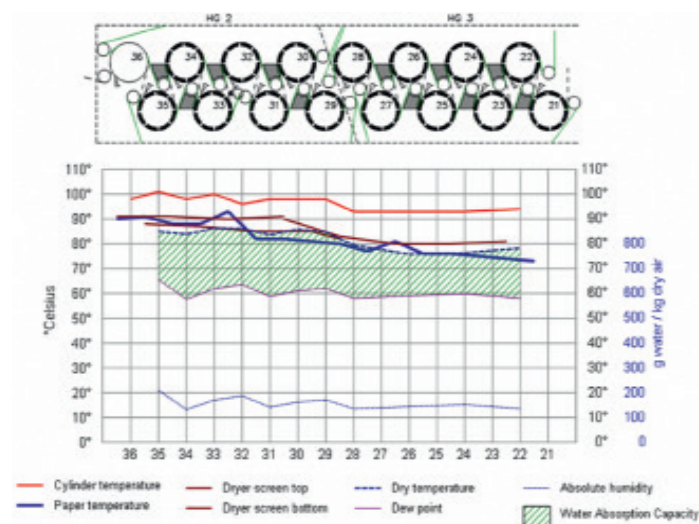
The objective of a dryer section analysis is to check the conditions inside the dryer hood by measuring pocket air conditions and the surface temperatures of clothing, paper sheet and drying cylinders. The dew point as well as the relative and absolute moisture are worked out from dry and moist air temperature.

To achieve this, measurements are taken at approximately 50cm from the front side of the paper sheet. Measuring the cylinder temperatures provides information about the course of the heat curve in terms of the necessary uniformity of the temperature increase as well as about potential irregularities (such as “flooded” cylinders). It also allows statements regarding superfluous warming of the clothing in a slalom group by e.g. inner cylinders. It is necessary to keep an eye on the temperature of the paper sheet in order to avoid problems such as fibre deposits at the first few drying cylinders. Generally, a uniform increase of the cylinder temperatures and therefore also those of the paper sheet should happen. Too much of a difference between the two will lead to fibre plucking and even to complete rupture of the paper sheet. In the diagram you can see dry temperature, dew point and absolute air humidity. The difference between dry temperature and dew point is marked by hatching. The larger the difference, the higher the water absorbency of the air and the faster the moisture can be evacuated.

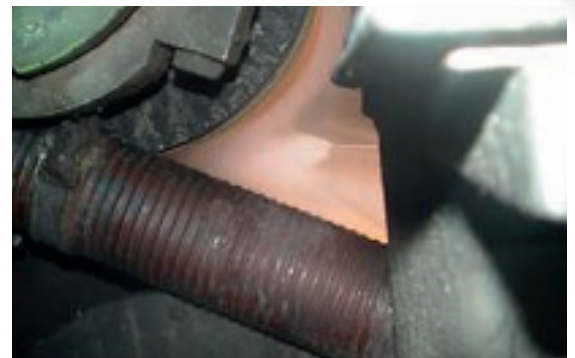
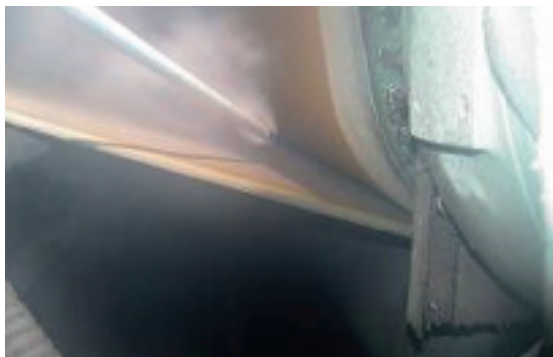
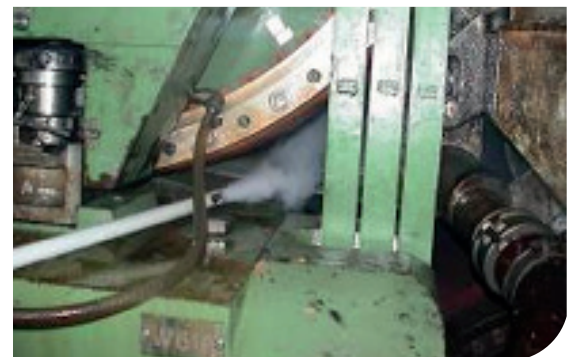
Visualization of air flows is achieved by introducing mist plus photo and video documentation of the now visible air flows. In order to find root causes for uncontrolled, or unwanted air flows, for example, measurements of the air speeds are conducted.

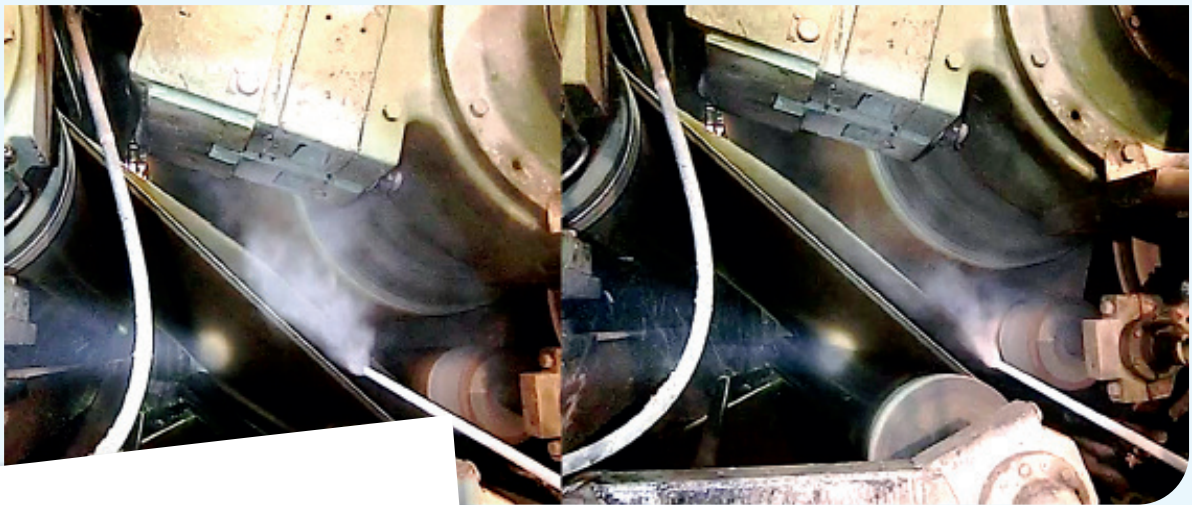
In order to visualize this belief and therefore also to prove we then made the airflows visible with the aid of a misting machine and documented them with a video camera. It became clearly visible that air flowed between felt and paper sheet in the direction of the front side.

This air was drawn back into the machine, around the paper edge, over the sheet, and thus produced the problematic edge fluttering. The following measures to resolve the problem were suggested:

- 1)** Install an air deflector directly next to the felt lead roll and thus direct the airflow against machine direction.
- 2)** Install a "suction tube" under the felt in order to suck the airflow through the felt and at the same time keep the sheet on the felt.

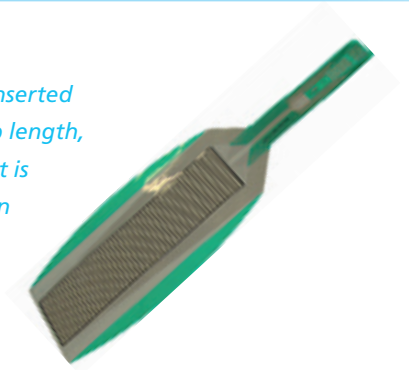
In order to examine presses Heimbach uses special single sensors that are inserted next to each other in the nip. Force and contact area are measured and nip length, pressure distribution and line force calculated from that. This measurement is often repeated with different settings in order to achieve clear information about force distributions and the related nip lengths.

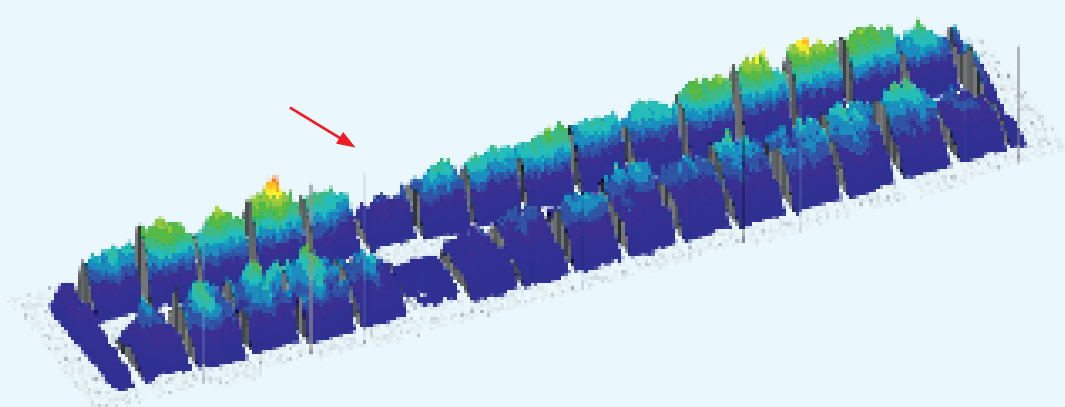
Therefore, the measurement was conducted without oil pressure between shoe and belt. Subsequently the relevant calibration data were added to it and evaluated. The force distribution in CD showed conclusively that hardly any force arrived in one location in the nip. The 3D representation of this force distribution illustrates this visually.

Therefore, it became clear that the wet streak in the sheet originated in the shoe press. In order to gain more accurate information, the customer had the press removed and checked by the manufacturer. It emerged that the shoe was warped. The customer suspected that a broken felt in the PM was responsible for the deformation of the shoe in this way. The pressure pistons of the shoe press were checked, and a new shoe was fitted. Moreover, a new felt was installed and the machine was restarted. The wet streak that had been visible before in paper and felt had disappeared.
