Heimbach-TASK Catalogue of Services

task.
Technical Assistance,
Service and Know-how

wherever paper is made

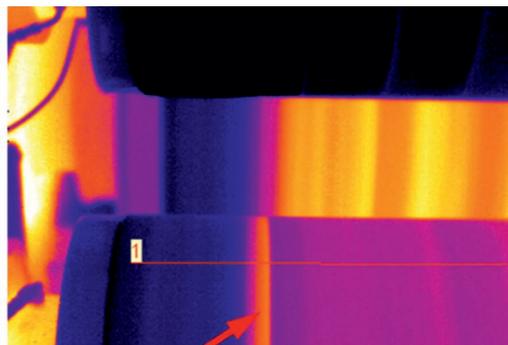
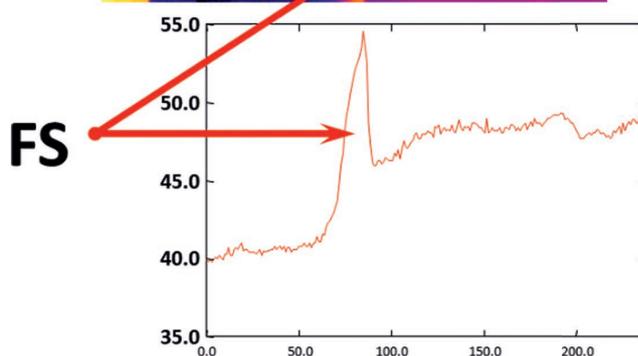
Thermography allows contactless registering and subsequent visual presentation of temperatures. The camera measures the infrared radiation emitted from an object and allows the surface temperature to be rendered in color. Surfaces with little emission, such as bare metals, reflect significantly more heat radiation than they emit and therefore are not suitable for capturing by an IR camera/sensor.

As a rule, starting at the reel spool, images are taken, tracking the error in the machine. In the area of the forming section no temperature difference between high and low dryer contents is detectable most of the time, as fibres and water still have the same temperatures at that point.

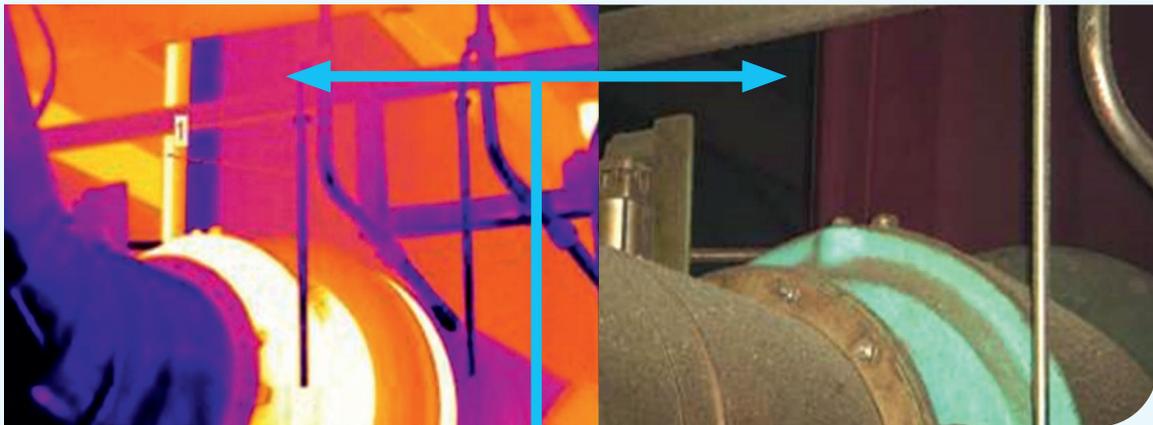
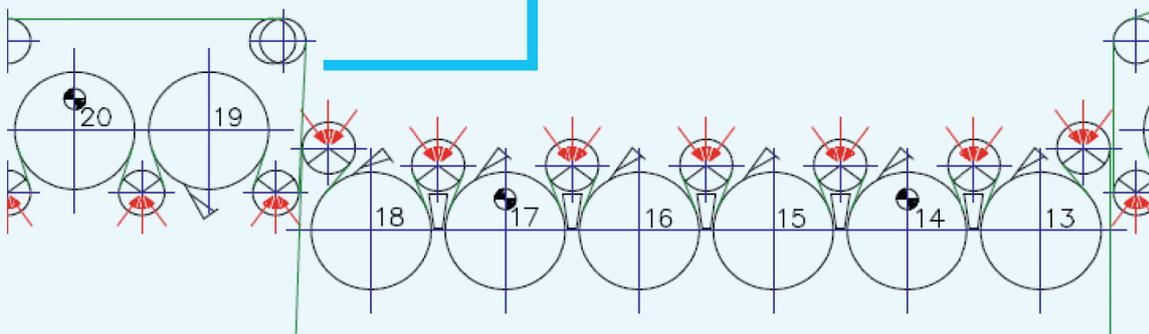
A customer complained about increased moisture at the sheet edge at the front side, which forced him to reduce the machine speed by up to 50 m/min for some grades. Heimbach-TASK carried out a thermography measurement, starting at the reel-up. The wet edge was clearly visible up to cylinder 19. Before this cylinder the temperature was distributed evenly across the sheet width.

Then the clothing was checked more closely, and the cause of the wet edge of the sheet could be determined. The dryer fabric, which ran in the slalom group from cylinder 19 onwards, was contaminated with oil at the front side edge. The fabric lost its tension and therefore also its pressure in the oily area, compared to the rest of the sheet width. In addition to this the air permeability of the fabric was different because of the oil contamination.

During the next machine shut the oil leak was found and sealed. Furthermore, the cylinders and vac rolls were cleaned at the front side in order to remove the oil residue. After that a new dryer fabric was installed and the machine was re-started. After the start-up phase no wet streak was detectable. Thus, the machine achieved its full production speed once again. In the following month this speed increase meant increased production of 100s of tons. Moreover, the lifetime of the dryer fabric was extended considerably.

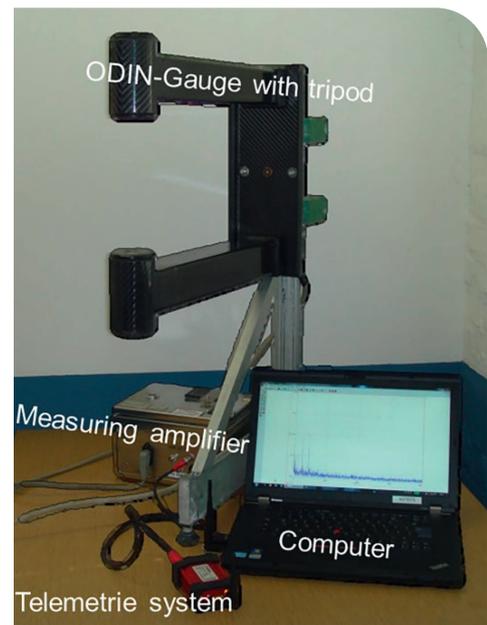
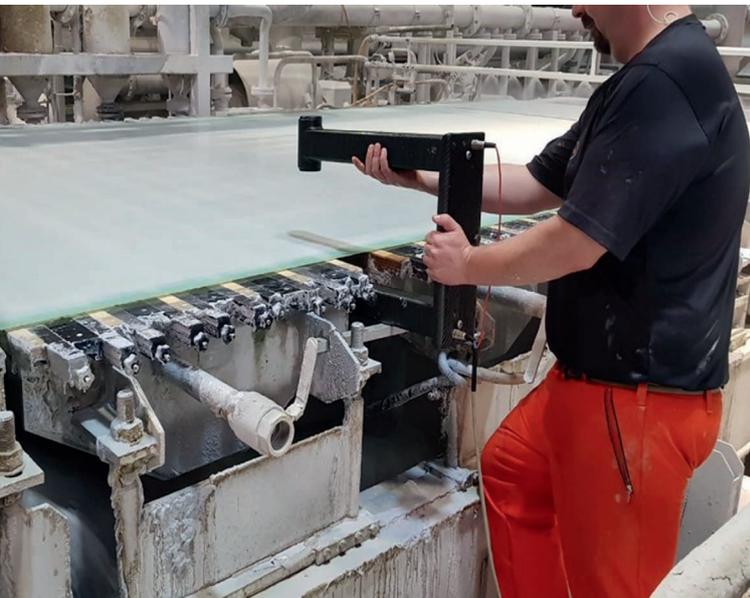
The term “barring” refers to markings that occur in the paper sheet in cross direction. Mostly it means variations in mass. Often these mass variations cannot be detected by the online diagnostic systems because their scanning rates are generally too low, even during point measurement. This is why we measure such mass variations with our mobile ODIN system (scanning rate 3000 Hz).

These series of measurement start before the roll-up. Subsequent measurements are carried out at all accessible positions in order to localize the root cause.

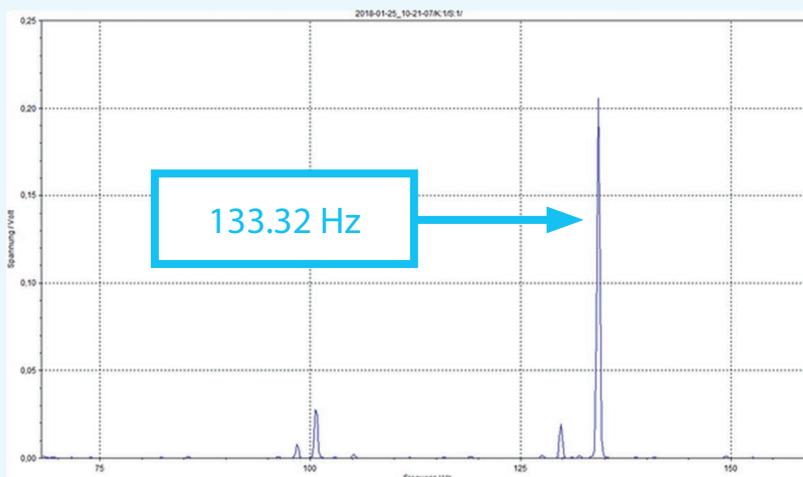
By using the ODIN fork barring was detected immediately before the reel-up (133.32 Hz). Following that it was also found in front of the calendar, in front of the size press and immediately behind the headbox. Therefore, the likelihood of the causal factor being found in the approach flow system was very high. The TASK team followed the stock against the flow direction. Before the headbox a pulsation damper was situated, which, however, could be excluded as causal factor: It does not contain any rotating parts and is therefore unable to cause any interfering frequencies. In front of the pulsation damper there was a pressure screen. Here a rotating frequency of exactly 33.33 Hz was measured.

The technical specifications of the vertical screen showed that the rotor had four blades. This meant: Rotating frequency (33.33 Hz) x 4 blades = 133.32 Hz!

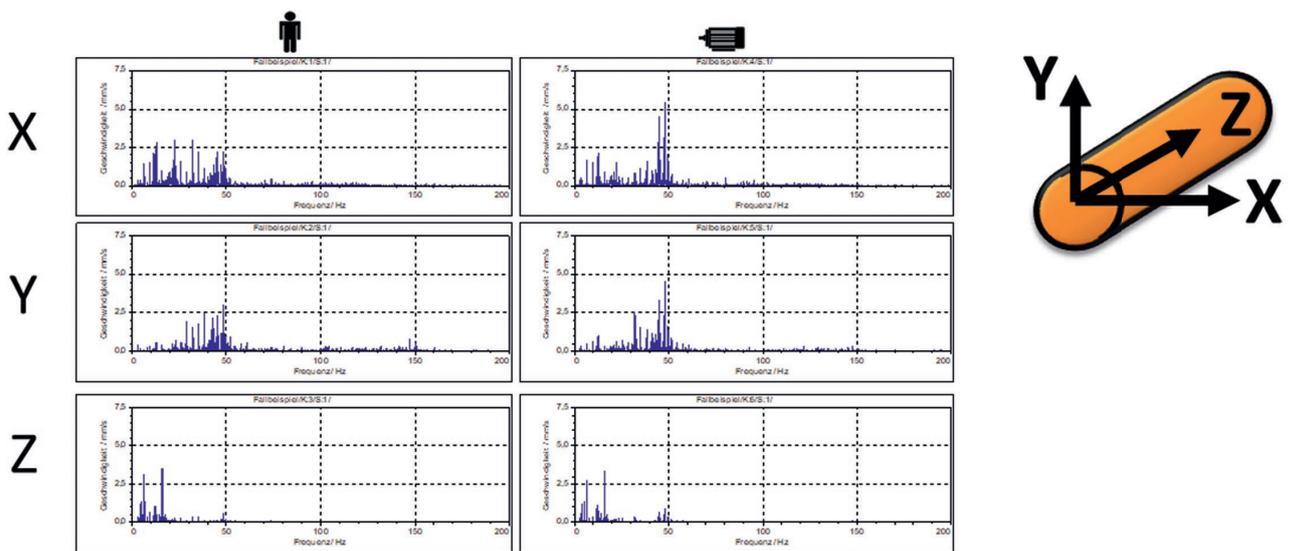
The triaxial acceleration sensors used by us pick up the horizontal, vertical and axial movements of a rotating component at the same time. The raw data (vibration measurement) of the acceleration sensors are transmitted to the computer via telemetry and are processed by its software.

Thus, a graphic representation of the FFT is possible (see diagram). The acceleration sensors in the press section are primarily attached to the bearing housings of the rolls. Every measurement takes place simultaneously at the front side and the drive side of the respective roll.

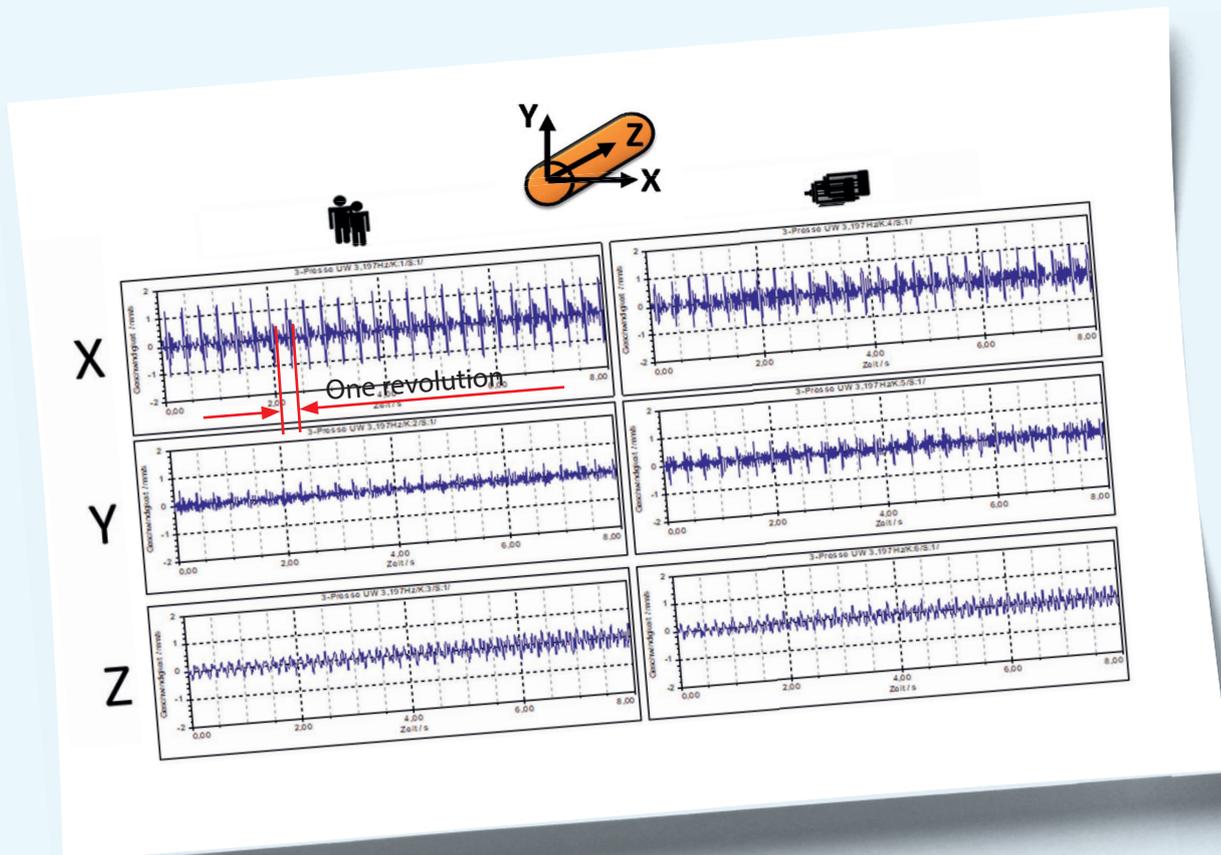
A customer noticed very intensive vibration in his press section but was unable to localize the root cause. We carried out a vibration measurement. We put the acceleration sensors one after the other on the bearing housings and recorded the vibration velocities of each press roll in the press section. Additionally, the rotational frequencies of the rolls, by means of IR sensor, were measured in order to match the timings of the interference signals to the rotating parts of the machine.

The time signal of the press belt in the shoe press showed clearly that once per rotation the belt swung/shifted horizontally. This led to extremely strong vibrations in the entire press section. The next day the belt was removed and checked. It was damaged on the inside over an approximately 30cm long area, which made the press section to vibrate once per rotation.

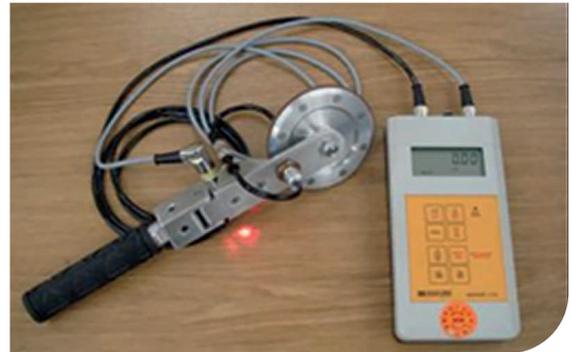
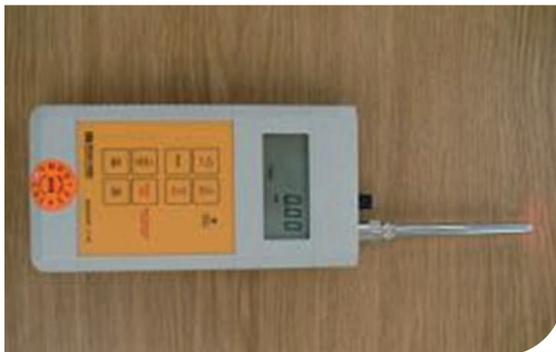
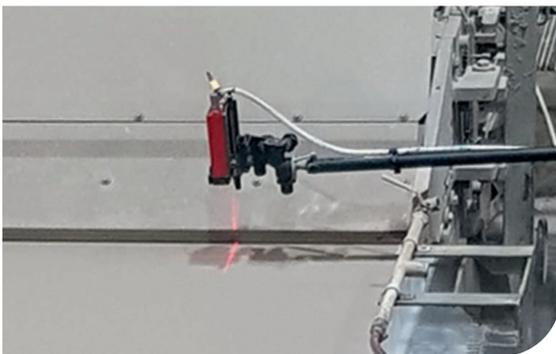
In order to determine surface speeds of rolls, fabrics, felts, etc., an inspection using the highly accurate length and speed measuring wheel is sufficient. The measuring wheel used by TASK contains a special rubber cover which ensures that there is hardly any slippage occurring between measuring wheel and material (such as wet fabric).

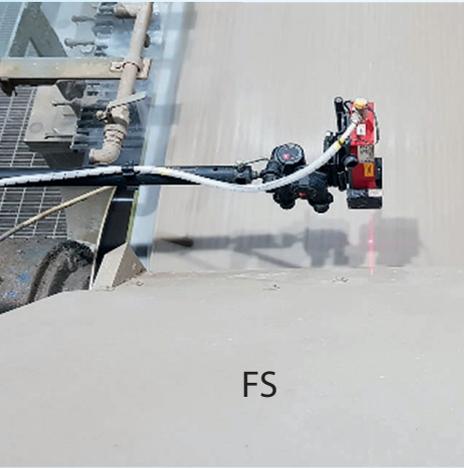
FS

A customer noticed quality differences of the sheet across the machine width. He had detected that the fibres on the front side were orientated more strongly in cross direction than on the drive side.

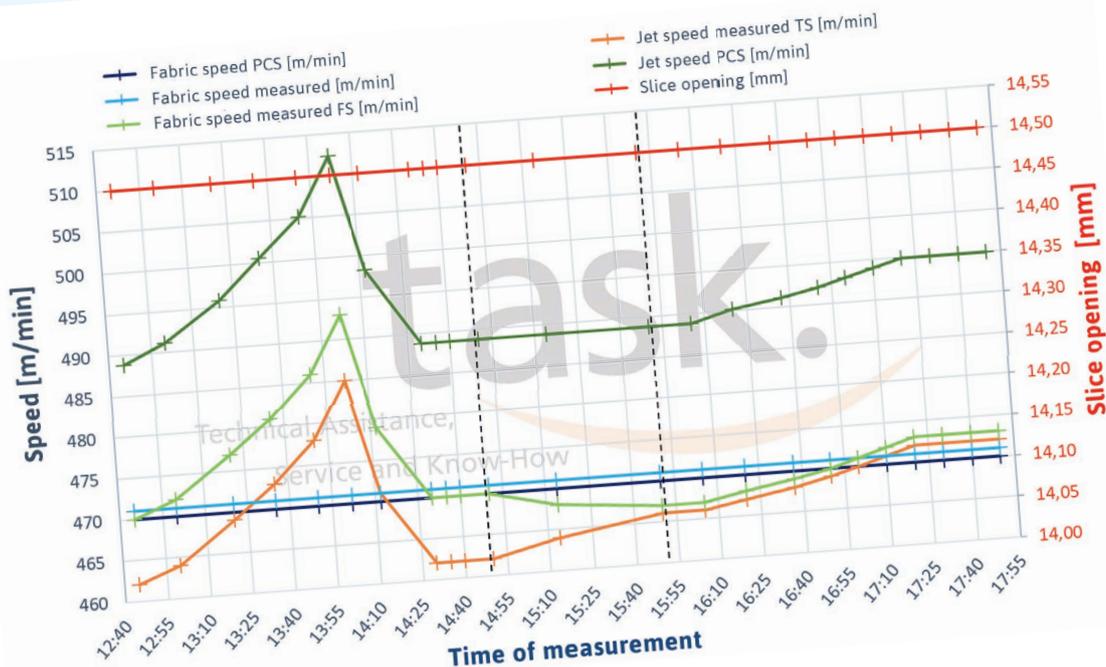
After we had measured the speeds of clothing and rolls in the forming and press section, we set up two lasers in order to measure the jet velocity in parallel on front side and drive side. It became obvious very quickly that the jet on the drive side was approx. 8 m/min slower than on the front side. In addition, the jet on the front side was 19 m/min slower than shown in the PCS.

As a test we changed the jet velocity in the PCS in order to see whether the measurement would show the same result. This worked perfectly (see diagram: 12.40-14.30 hours) and meant that the control of the

headbox pump and the corresponding programming in the PCS were functioning. At each setting the difference between the jet velocity shown and measured was identical. We then looked for the cause of the variation between front side and drive side. There had to be a pressure difference in the headbox which could in all probability only come from the cross-flow spreader. And that is what we found. The return flow was too restricted. We opened this return flow slowly, and the jet velocities of front side and drive side started to converge. When the return flow was opened fully the difference between front side and drive side was only 1 m/min (diagram: 14.50-15.50). Subsequently we increased the jet speed so that the customer was once again able to produce even paper quality. Then (from 18.00 onwards) we changed the slice opening of the headbox incrementally in order to see whether the jet speed remained constant, which is what it did. Therefore, by the end of the day we had established: the customer only needs to program an offset (22 m/min) and the correct jet speed would be displayed in the PCS.

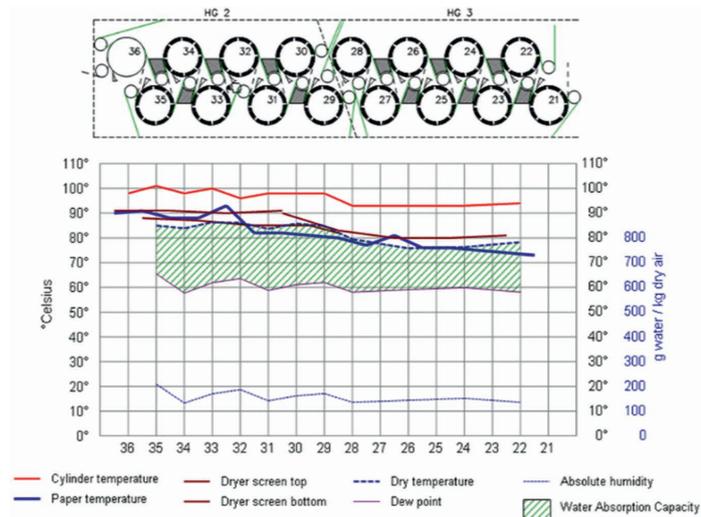
The objective of a dryer section analysis is to check the conditions inside the dryer hood by measuring pocket air conditions and the surface temperatures of clothing, paper sheet and drying cylinders. The dew point as well as the relative and absolute moisture are worked out from dry and moist air temperature.

To achieve this, measurements are taken at approximately 50cm from the front side of the paper sheet. Measuring the cylinder temperatures provides information about the course of the heat curve in terms of the necessary uniformity of the temperature increase as well as about potential irregularities (such as “flooded” cylinders). It also allows statements regarding superfluous warming of the clothing in a slalom group by e.g. inner cylinders. It is necessary to keep an eye on the temperature of the paper sheet in order to avoid problems such as fibre deposits at the first few drying cylinders. Generally, a uniform increase of the cylinder temperatures and therefore also those of the paper sheet should happen. Too much of a difference between the two will lead to fibre plucking and even to complete rupture of the paper sheet. In the diagram you can see dry temperature, dew point and absolute air humidity. The difference between dry temperature and dew point is marked by hatching. The larger the difference, the higher the water absorbency of the air and the faster the moisture can be evacuated.

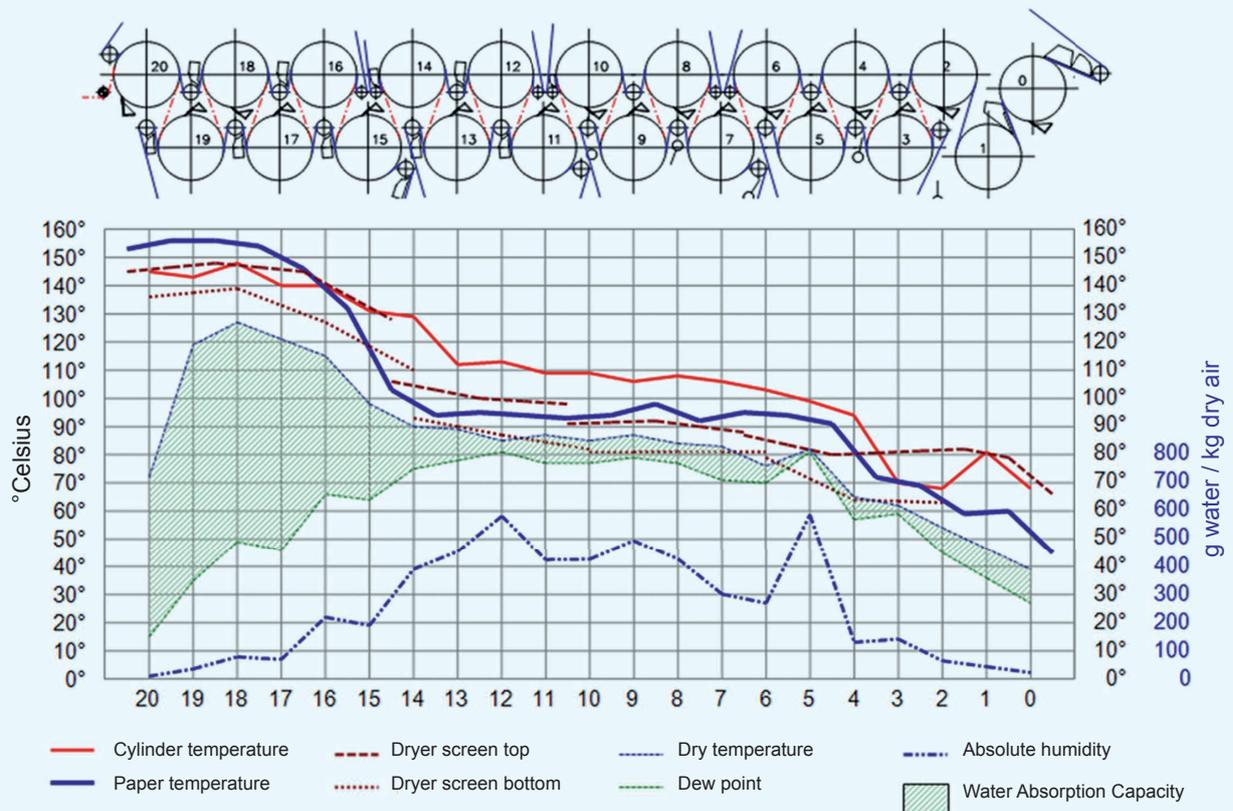
A customer requested a dryer section analysis because he wanted to optimise his machine in terms of speed. He specifically asked for this measurement because he himself had identified the dryer section as a bottleneck area within his process. The machine to be examined was a decor paper machine: This was evident by measurement value display of the dryer section, which indicated a higher paper temperature than cylinder temperature from cylinder 16 onwards.

We found that the dryer section was running at maximum capacity, meaning that the water absorbency of the air was under 10°C for the first 13 cylinders. Additionally, the clothing temperatures were very close to the dew point; for cylinder 5 even below. This meant there was great danger of condensation of the water vapor in the pocket air to reach the clothing and consequently to remoisten the paper. However, there was an area in the hood where enough hot air intake was available (Cyl. 15-20). Underneath cylinders 0-12 we found an "undercurrent" which clearly was not very efficient. Unfortunately, this undercurrent did not reach the cylinder pockets where it was needed, because of a large extent it moved past the paper sheet on both front and drive side and ended up as exhaust air. When the hot air of the undercurrent is directed straight into the cylinder pockets of the first 13 cylinders the water absorbency is increased enormously. In this way the machine speed can be increased without increasing energy costs for the ventilation of the pockets. Therefore, our recommendation is: "Replace undercurrent with efficient pocket ventilation". This is achieved very well by using blow pipes or blow doctors.

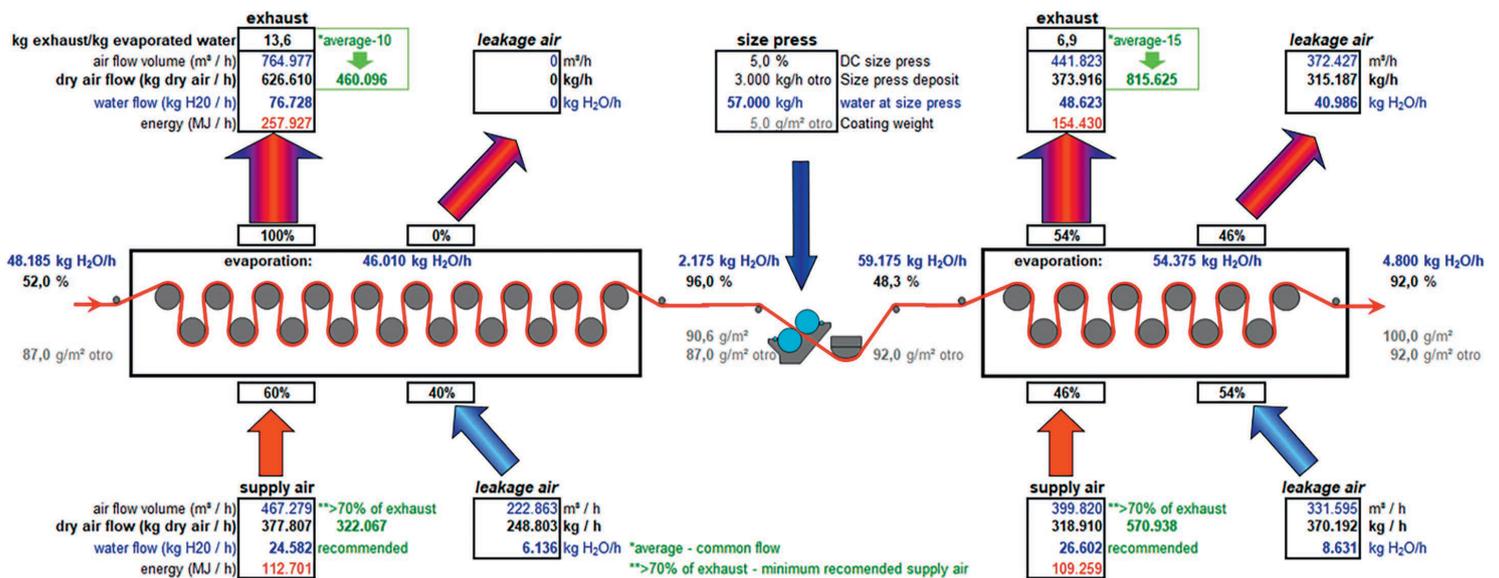
When balancing a dryer hood the quantity of water to be evacuated is calculated. However, to be able to evacuate it an appropriate air volume is needed. Experience shows on average that this air volume is around 10 kgs dry air per 1 kg water (pre- dryer). Depending on paper grade and production output the evaporation rates vary. Therefore, a hood balance should be performed at the production output that yields the highest evaporation rates in the dryer section.

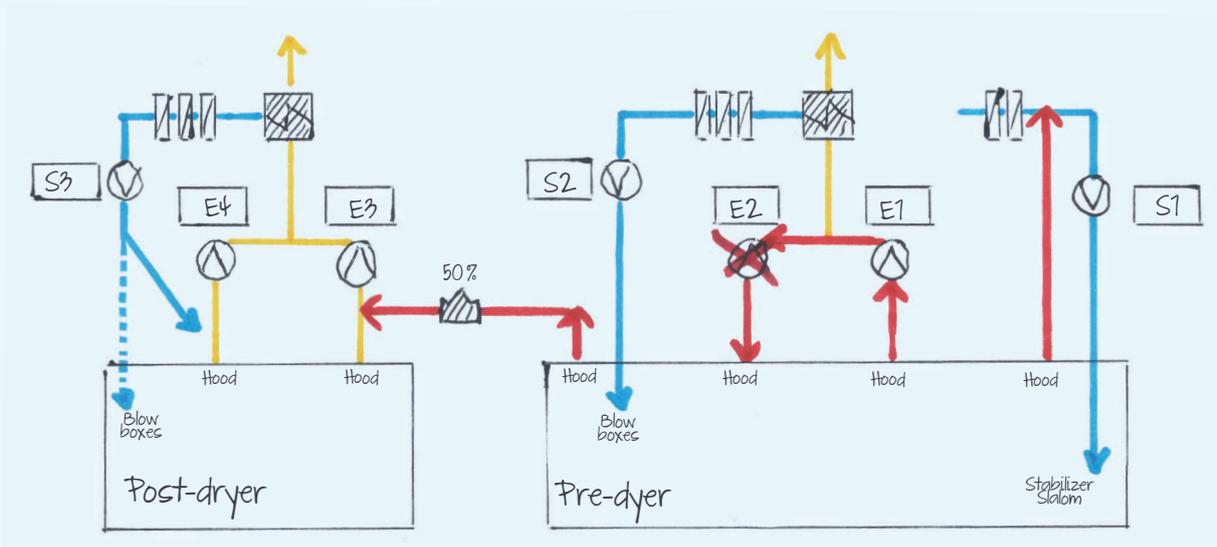
A customer's machine had been running more slowly for a short time because, according to the customer, the paper sheet would have become too moist otherwise. Therefore, TASK conducted a hood balance (as shown in point 6.). This hood balance showed clearly that something was not right with the exhaust ventilation of the pre-dryer. For one thing this exhaust air was very moist and for another it did not reach the air/air-heat exchanger. As even repeated measuring did not make things clearer we took a closer look.

One of the exhaust ventilators of the pre-dryer section turned in the wrong direction. How was this possible? The drive belt for power transmission from motor to fan was torn. The airflow, evacuated by the other exhaust air ventilator, pushed it in the wrong direction. This meant the air was not transported outside but was returned into the dryer hood. The hot, moist air was circled around rather than evacuated.

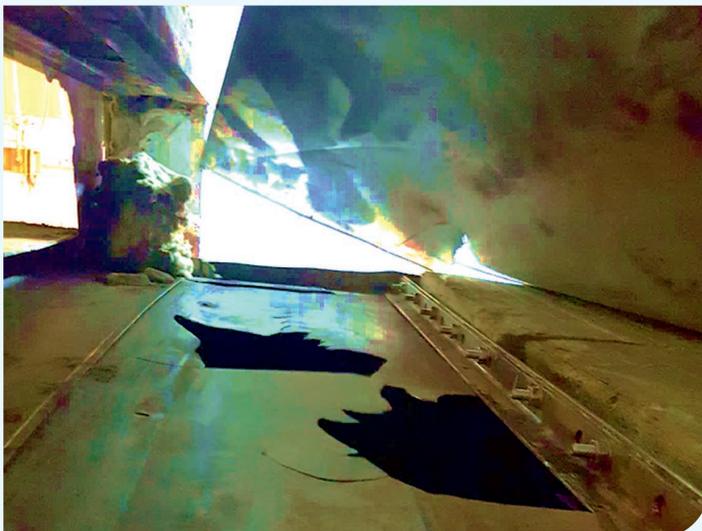
This effect was intensified by the design of the exhaust duct, which impeded air extraction. Therefore, the heat exchanger did no longer work efficiently, and the hot air intake became noticeably colder. As a result, the paper sheet dried more slowly, and the customer was forced to reduce the machine speed considerably. And this with increased energy use! Matters were made worse by two very large holes in the air intake duct of the post-dryer,

behind the air intake fan. This meant that a large part of the heated, dry air intake was evacuated into the hall.

The drive belt of the exhaust ventilator of the pre-dryer was replaced and the holes in the air intake duct of the post dryer were closed. After this short shut time it was possible once again to start up the machine at its usual production speed.

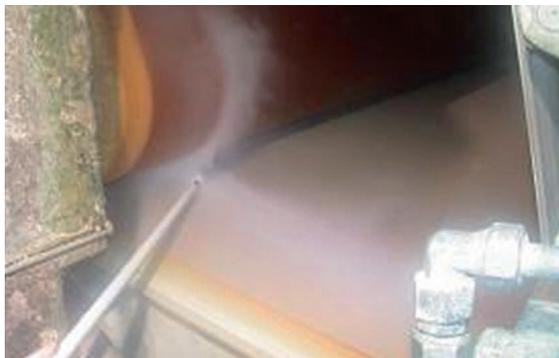
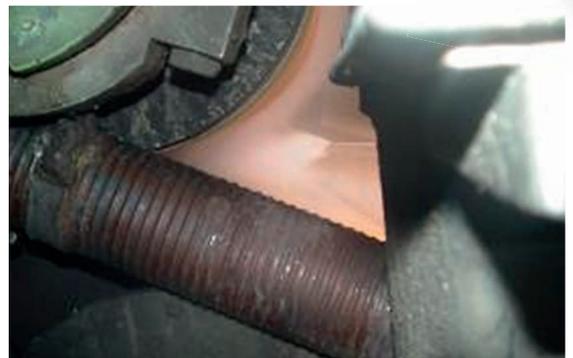
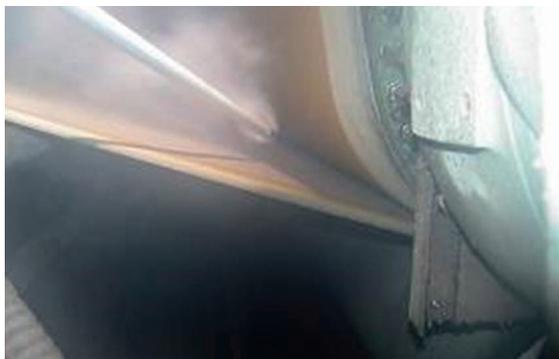
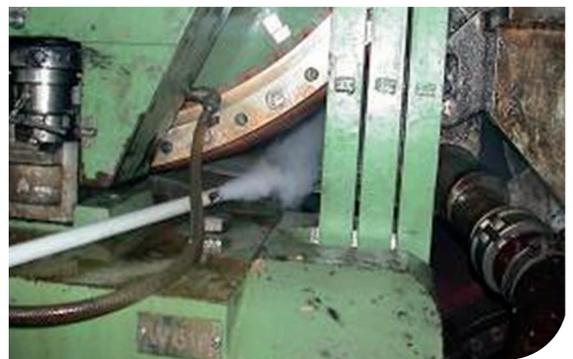
Visualization of air flows is achieved by introducing mist plus photo and video documentation of the now visible air flows. In order to find root causes for uncontrolled, or unwanted air flows, for example, measurements of the air speeds are conducted.

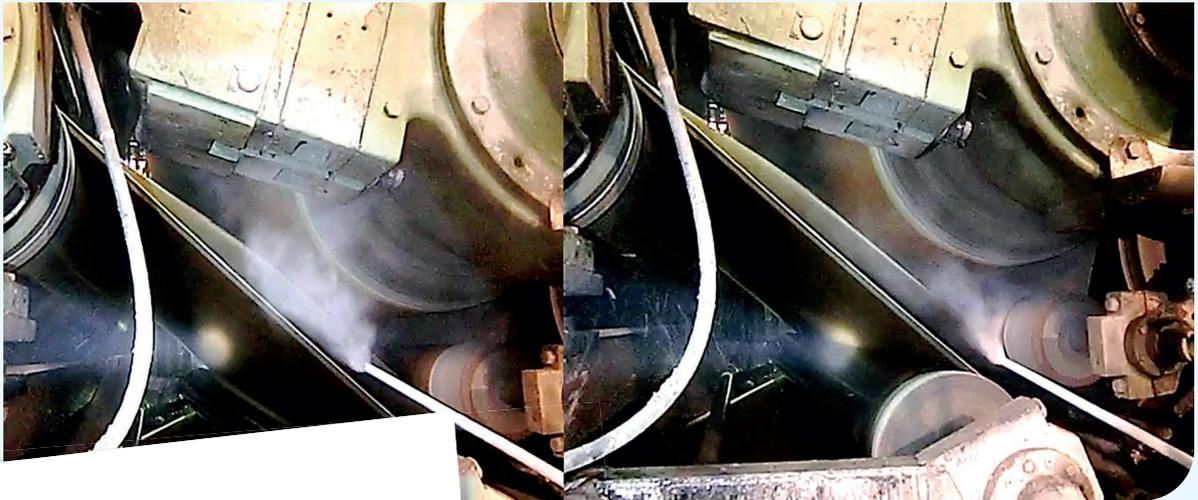
In order to visualize this belief and therefore also to prove we then made the airflows visible with the aid of a misting machine and documented them with a video camera. It became clearly visible that air flowed between felt and paper sheet in the direction of the front side.

This air was drawn back into the machine, around the paper edge, over the sheet, and thus produced the problematic edge fluttering. The following measures to resolve the problem were suggested:

- 1) Install an air deflector directly next to the felt lead roll and thus direct the airflow against machine direction.
- 2) Install a "suction tube" under the felt in order to suck the airflow through the felt and at the same time keep the sheet on the felt.

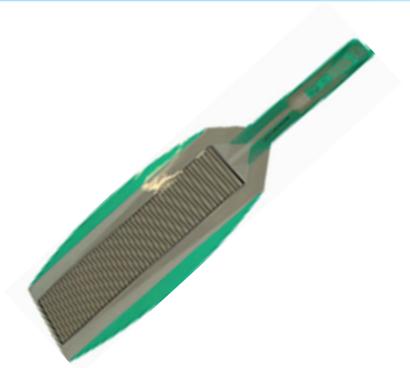
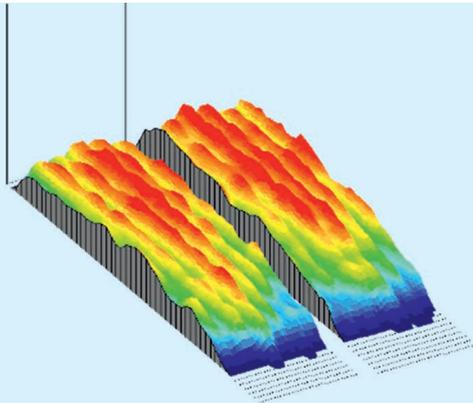
In order to examine presses Heimbach uses special single sensors that are inserted next to each other in the nip. Force and contact area are measured and nip length, pressure distribution and line force calculated from that. This measurement is often repeated with different settings in order to achieve clear information about force distributions and the related nip lengths.

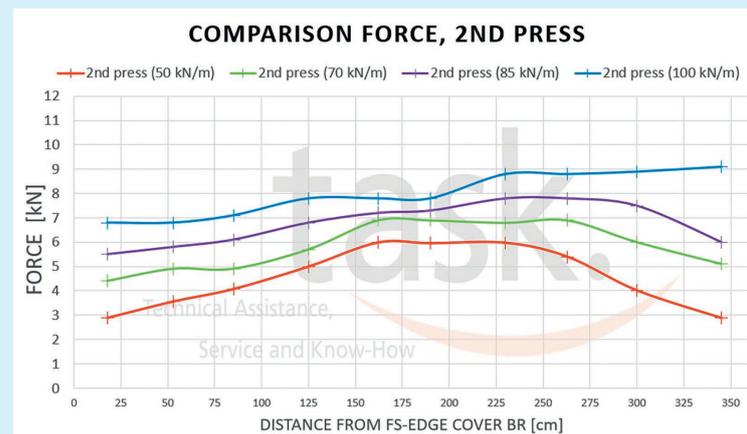
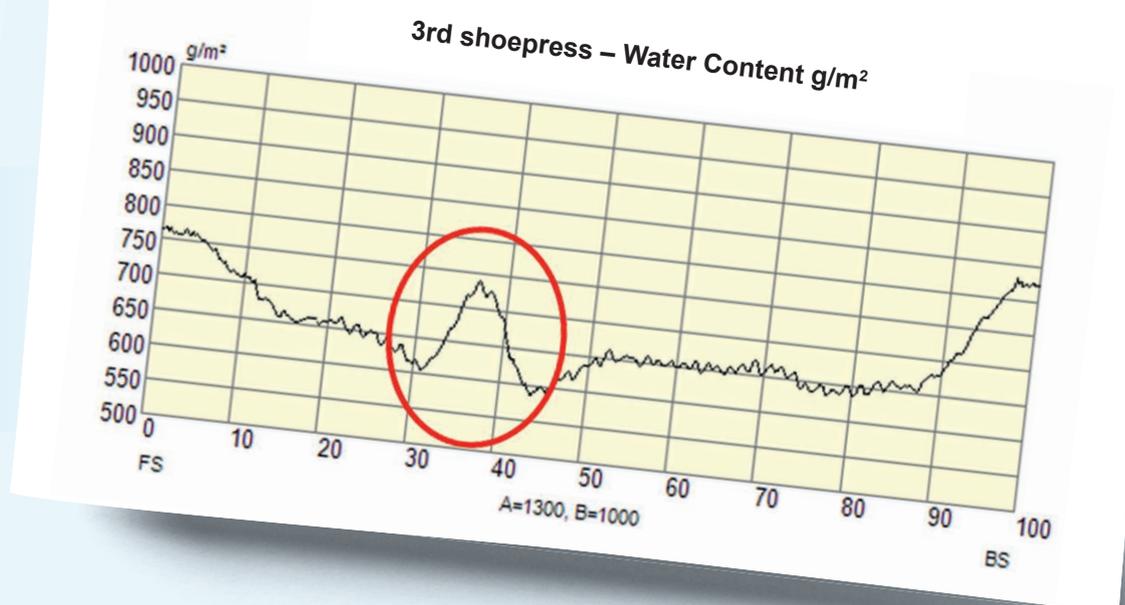
- Force and pressure distribution in the nip
- Nip length across the machine width
- Line force across the machine width and as an average
- Comparisons of the different settings

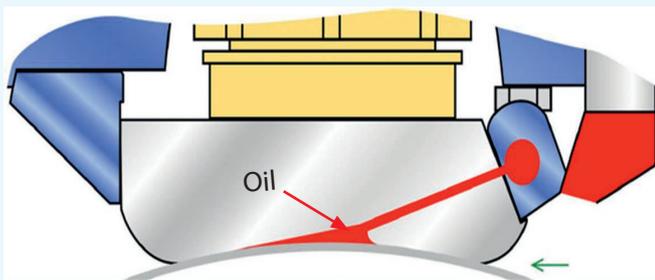
The shoe in this press was interrupted in the running direction of the machine. At this point pressure was created with oil (red in the diagram); this means the lubricant for the inside of the press belt is introduced directly into the shoe during operation. However, the oil could not be introduced in shut mode, which also concerned the nip profile measurement, because the press belt would have been saturated with oil.

A customer complained about a wet streak in the sheet having occurred for approx. 2 weeks. The root cause could not be explained. The Heimbach HOME Service measurements showed increased water content in the corresponding place of a felt. This felt only ran through the nip of a shoe press. And it was this shoe press TASK were asked to investigate.

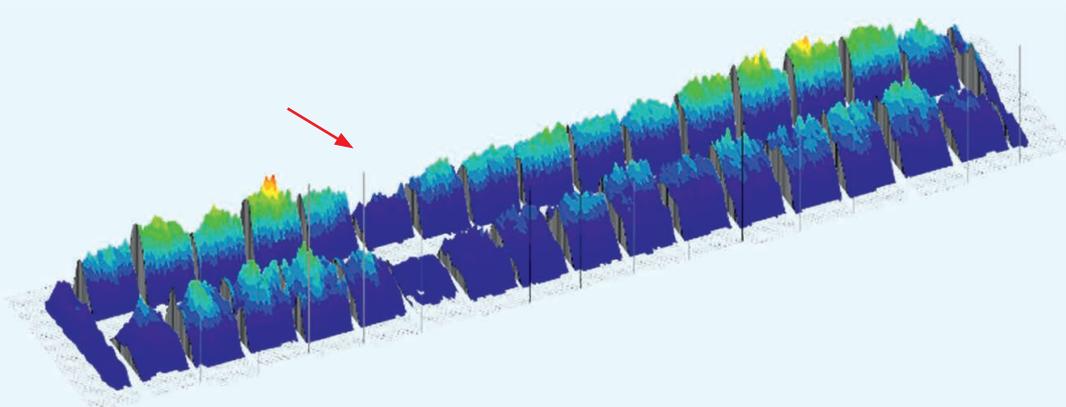
Therefore, the measurement was conducted without oil pressure between shoe and belt. Subsequently the relevant calibration data were added to it and evaluated. The force distribution in CD showed conclusively that hardly any force arrived in one location in the nip. The 3D representation of this force distribution illustrates this visually.

Therefore, it became clear that the wet streak in the sheet originated in the shoe press. In order to gain more accurate information, the customer had the press removed and checked by the manufacturer. It emerged that the shoe was warped. The customer suspected that a broken felt in the PM was responsible for the deformation of the shoe in this way. The pressure pistons of the shoe press were checked, and a new shoe was fitted. Moreover, a new felt was installed and the machine was restarted. The wet streak that had been visible before in paper and felt had disappeared.

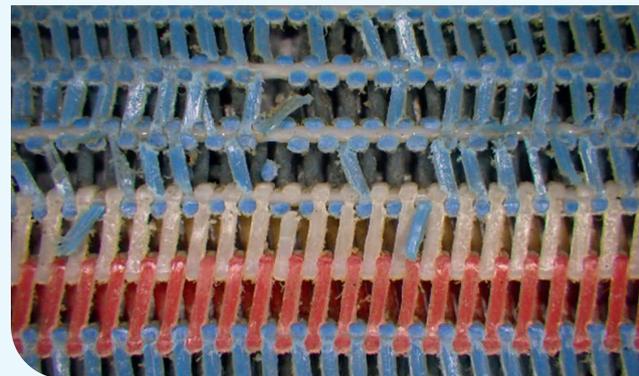
The dryer fabric in question – an unfilled spiral fabric – had been fitted in the third drying group. In the second drying group there were cleaning modules, on which we concentrated as a first step. We suspected that the spray mist from these cleaning modules was carried by the dryer fabric and was therefore transported to the guiding rolls. But the question remained: Why only those three guiding rolls? When the paper sheet broke we found the solution to the puzzle. Every time a sheet broke the cleaning modules switched on automatically. However, the collection tray of the upper cleaner was defective and the water ran directly onto the lower cylinder of the third drying group. This is why the spiral fabric distributed the water onto the three lead rolls in question, which, as a result, corroded much more quickly than usual. The customer repaired the collection tray, fitted three new lead rolls, and the dryer fabric achieved its planned lifetime once again.

A dryer fabric had to be exchanged every three weeks because it had abraded or even almost fallen apart across the entire surface area. The customer knew that the culprits were three corroded lead rolls. However, for us the question was why it was only those three lead rolls that were corroded in the entire dryer section.
